Important Medical Device Information

Cardiac Rhythm Management

September 2014

Summary

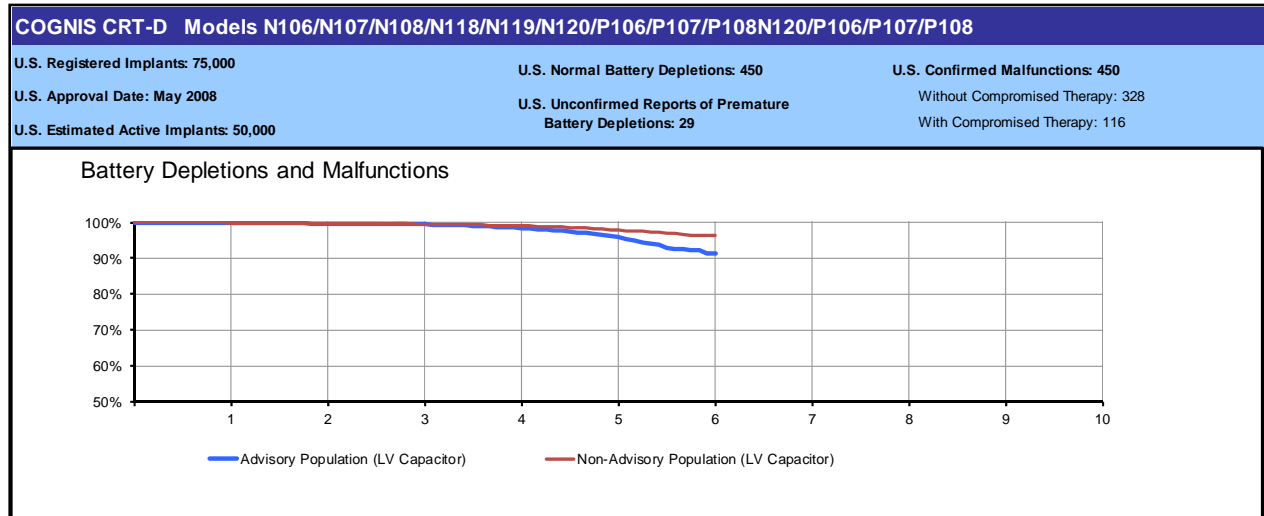
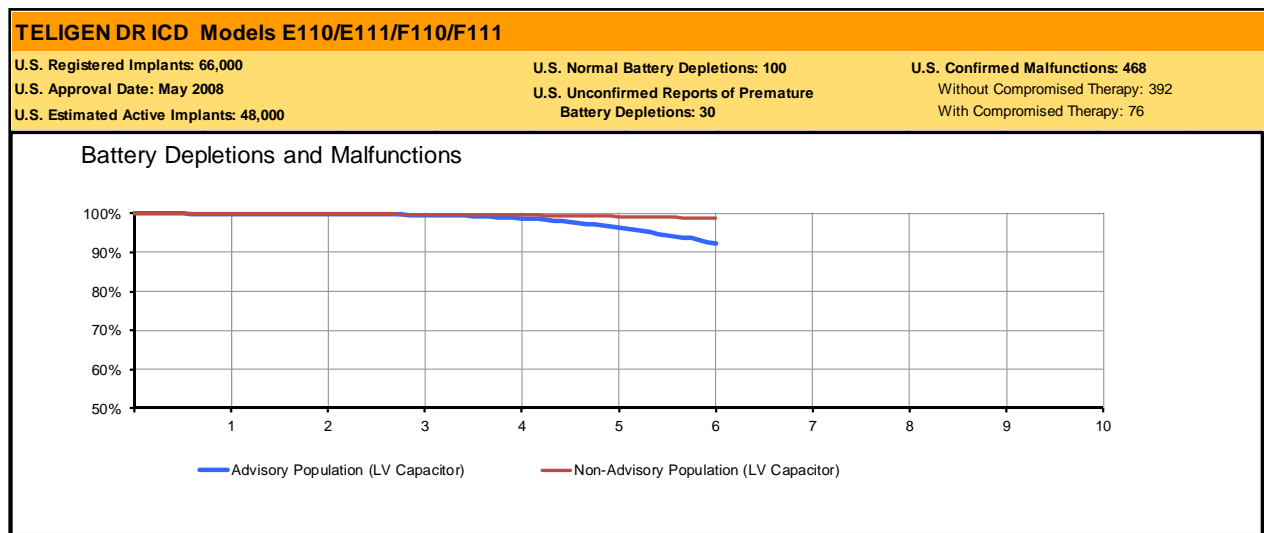
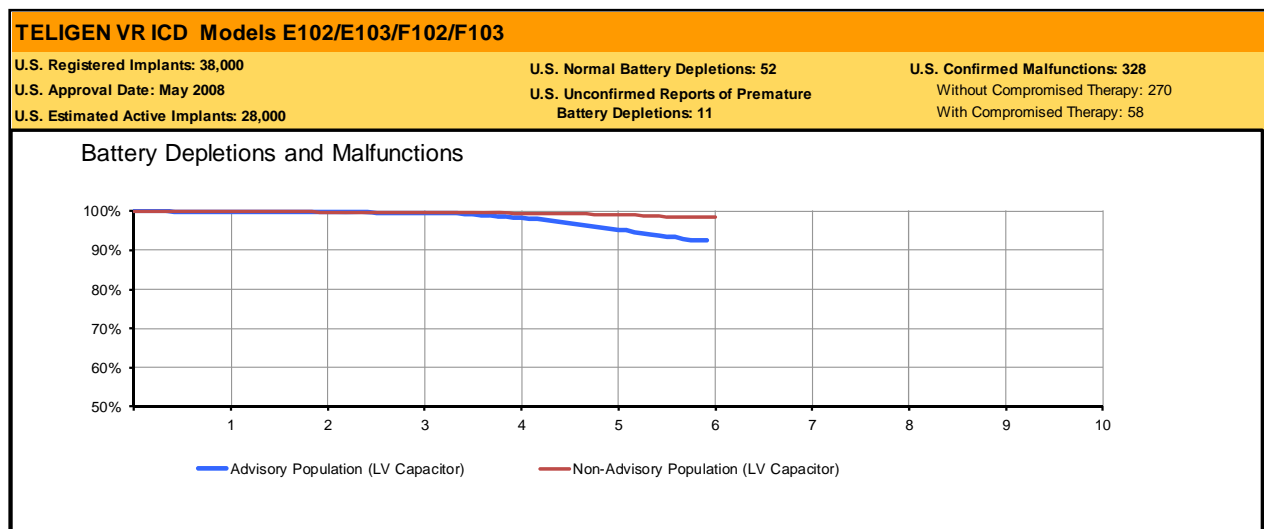
Appendix A

A total of approximately 267,000 COGNIS and TELIGEN defibrillators have been distributed and implanted since May of 2008. Overall Cumulative Survival, including normal battery depletion, is approximately 95% at 72 months (see Appendix A).

All-cause* Cumulative Survival for devices within and outside of the Low Voltage Capacitor Advisory subset population (United States data)

*Includes normal battery depletions and confirmed malfunctions.
