**Subject: Pacemakers – Technical programming information on Minute Ventilation Sensor.**

Ref.: 92186345-FA

Product name	Models
VALITUDE™ CRT-P	U125, U128
ACCOLADE™ Pacemakers	L300, L301, L310, L311, L321, L331
ESSENTIO™ Pacemakers	L100, L101, L110, L111, L121, L131
VISIONIST™ CRT-P	U225, U226, U228
PROPONENT™ Pacemakers	L200, L201, L209, L210, L211, L221, L231
ALTRUA™ 2 Pacemakers	S701, S702, S722

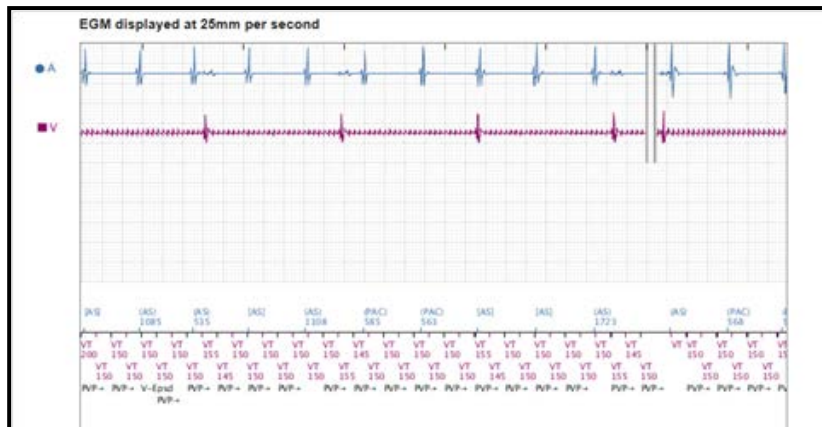
Figure 2. Example of MV signal oversensing

Boston Scientific pacemakers perform an MV lead check approximately every hour to assess lead and lead connection integrity. The active vector may be the primary vector (distal RA ring electrode to the pacemaker case) or secondary vector (distal RV ring electrode to the pacemaker case). Since either vector may be used to measure MV, at least one of the implanted leads must have normal bipolar lead impedances. Typically the MV sensor signal is appropriately filtered out by the pacemaker. However, if a high impedance condition is detected within the lead-pacemaker system, the MV sensor signal may be oversensed (Figure 2).

- For pacemaker-dependent patients, turn the MV sensor “OFF”. Note when programmed to passive, the MV sensor signal is enabled and may be oversensed. See Appendix B for details on turning the MV sensor “OFF”.

- In accordance with the pacemaker manual, if MV sensor signal artifacts are observed on EGMs and leads are performing appropriately, consider programming the sensor to “OFF” to prevent oversensing.
