# Urgent Field Safety Notice Product Correction

This Product Correction letter is to inform you of an issue with the ARCHITECT c Systems Mixer (LN 09D59-01, 09D59-02, and 09D59-03). There is the potential for the mixer blade, attached to the mixer with a screw and nut, to separate from the mixer. The missing mixer blade will result in inadequate mixing of the reaction mixtures leading to potential incorrect results (failed assay calibration, Quality Control (QC) out of range, and/or incorrect patient results). The impact on the test result may vary depending on the assay being performed and the viscosity of the patient sample.

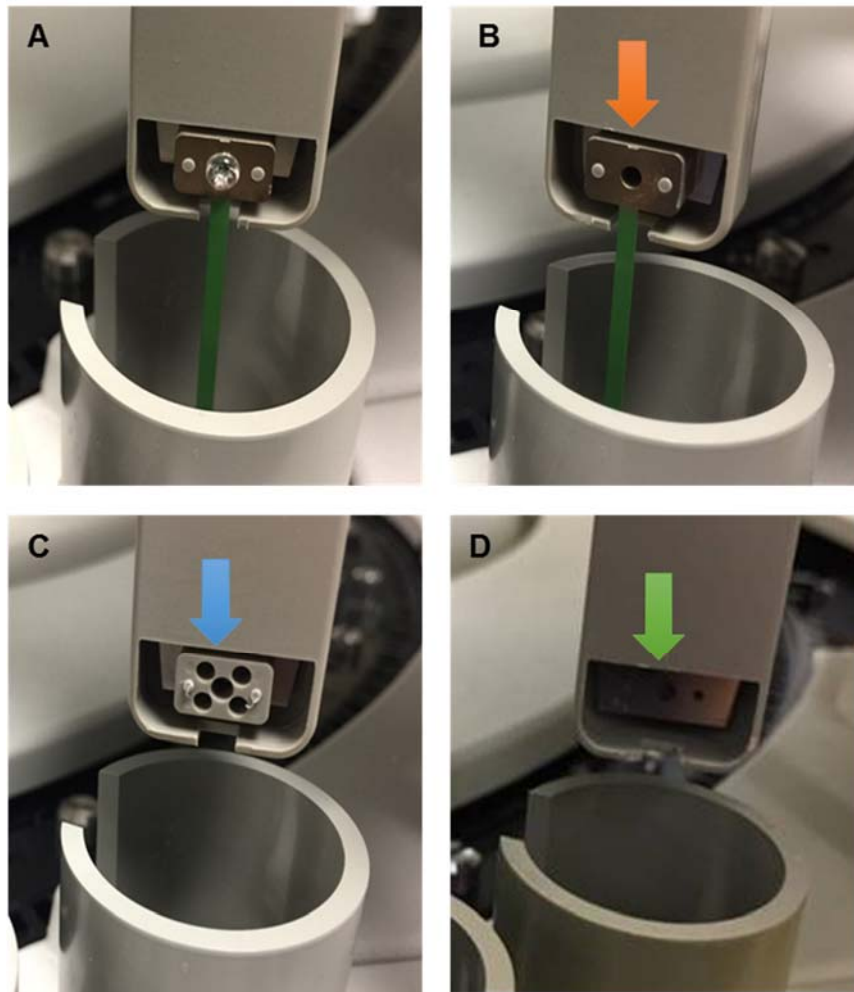
The following pictures show a A) normal mixer B) mixer missing the mixer screw (orange arrow pointing to missing screw), C) missing mixer blade with spacer shim present (blue arrow pointing to missing mixer blade), and D) missing mixer and spacer (green arrow pointing to missing mixer blade and spacer).

1. Replace broken mixer. Refer to *Replace the Mixer (c4000, c8000, c16000)*<sup>1</sup>.
2. Replace the cuvette dry tip. Refer to *Replace the cuvette dry tip (c4000, c8000, c16000)*<sup>1</sup>.
3. Follow the instructions in **Appendix C** to inspect all cuvettes to ensure that the screw or nut did not fall into an individual cuvette.

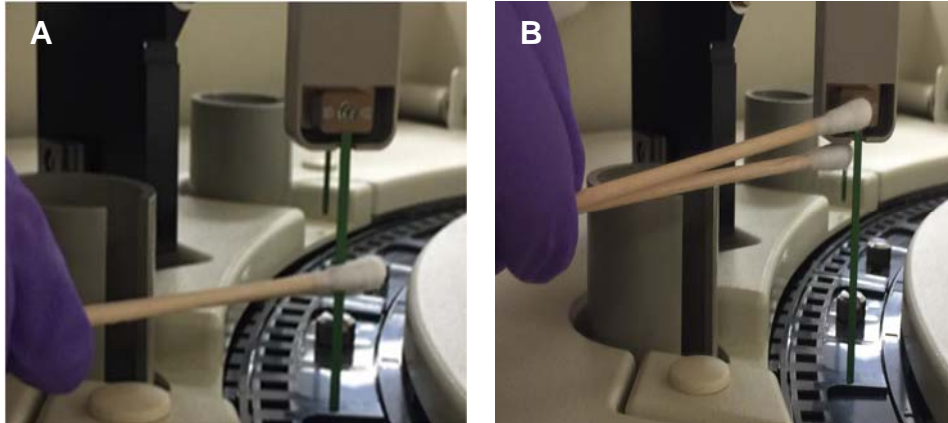
The below pictures show A) the proper cleaning of the mixer and B) improper contact of the 70% isopropyl alcohol with the mixer screw.

When performing weekly maintenance procedure *6021 Clean Mixers*<sup>1</sup>, it is recommended to not let the mixer screw and 70% isopropyl alcohol come in direct contact.
