Safety Notice

SCHILLER CARDIOVIT AT-102 ECG

HPRA Safety Notice: SN2023(01)

Issue Date: 13th September 2023

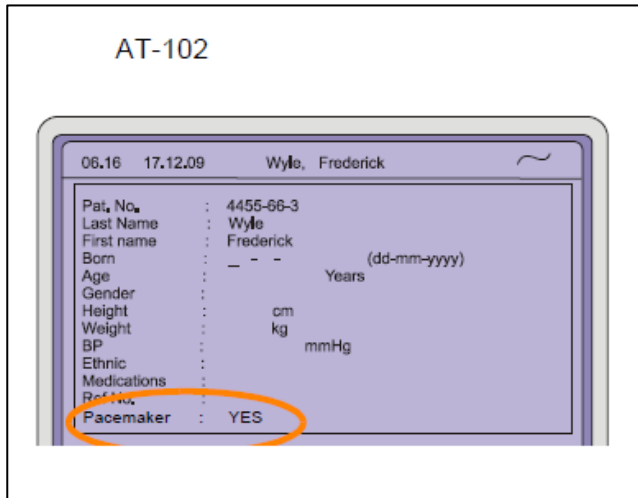
Schiller was notified of an incident where an ECG printout differed from the ECG that was seen in the database on the data management system. This behaviour was only found to occur under the conditions described the 'Issue' section of this HPRA Safety Notice.

Figure 1 - Ensure that the 'Pacemaker' field is correctly selected prior to performing the ECG (image copied from the IFU addendum for the Cardiovit AT-102 / AT-102 Plus / AT-10 plus /AT-104 PC / CS-200 / MS-2010 / MS-2015)

To reduce this risk of ECG distortion **the manufacturer has advised that, for patients with a pacemaker in situ, when entering new patient's details ensure that the 'Pacemaker' field is correctly ticked / selected 'YES', prior to performing the ECG** (see figure 1). This will avoid distortion of the transmitted ECG.
