## **URGENT – Field Safety Notice**

### **Philips HeartStart MRx Monitor/Defibrillator**

#### **Two Issues with MRx Housing Could Pose Risk to Patients or Caregivers**

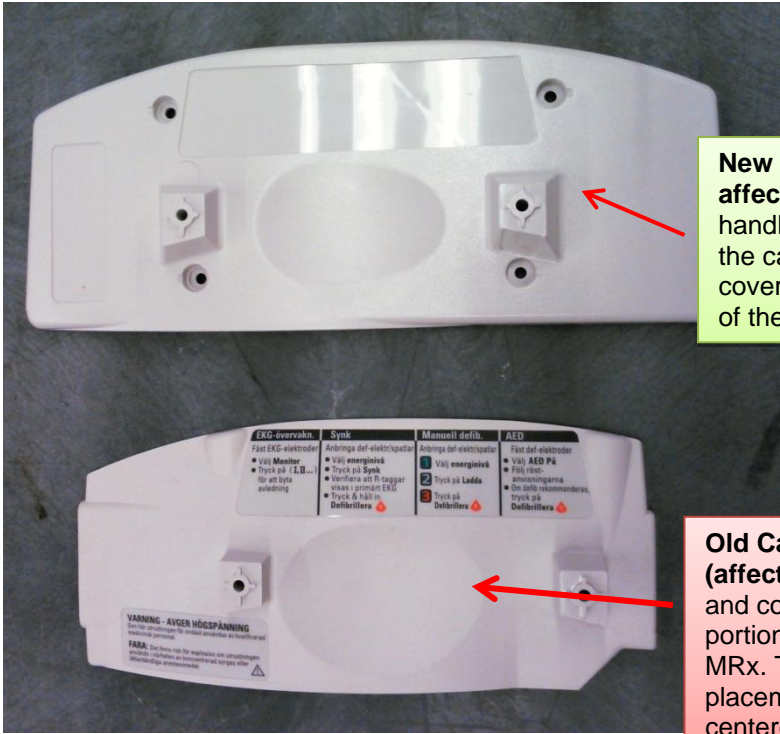
<p><b>HOW TO IDENTIFY AFFECTED PRODUCTS</b></p>	<p>Philips HeartStart MRx Monitors/Defibrillators (1) within the identified serial number range <b>AND</b> (2) meeting one or both of the conditions below are affected by the issue.</p> <p><b>Condition #1: Device has EtCO2 Option</b></p> <p>Devices with the EtCO2 option are affected. To determine if an MRx has the EtCO2 option, press the Menu Select button to open the Main Menu. Use the Navigation and Menu Select buttons to select <b>Other</b>, followed by <b>Print Device Info</b>. Devices with EtCO2 option have 'etCO2' printed under 'Options' on the printed strip.</p> <p><b>Condition #2: Device has Old Cap Plate</b></p> <p>Devices with the old cap plate, shown below, are affected. Devices with a paddle tray or the new cap plate are not affected.</p> <div data-bbox="402 1003 1404 1751">

<div data-bbox="1096 1138 1404 1344"><p><b>New Cap Plate (NOT affected)</b> positions the handle in the middle of the cap plate and covers the entire top of the MRx.</p></div><div data-bbox="1079 1516 1404 1751"><p><b>Old Cap Plate (affected)</b> is shorter and covers only a portion of the top of the MRx. The handle placement is off-centered on cap plate.</p></div></div>

<b>ACTION TO BE TAKEN BY CUSTOMER / USER</b>	<p>You can continue to use your MRx prior to receiving the hardware upgrade provided that you follow the steps provided below.</p> <ol style="list-style-type: none"><li>1. The CO2 FilterLine fitting should not be forced into the CO2 Inlet Port. Rather, after inserting the FilterLine fitting into the port, the fitting should be turned clockwise to secure into place, per the MRx Instructions for Use.</li></ol> <p>If the Inlet Port becomes inaccessible during use, continue to treat the patient according to your organization's protocol.</p> <ol style="list-style-type: none"><li>2. If one or both sides of the handle are found to have separated from the MRx housing, continue to treat your patient per existing protocols. Do not use the handle to carry the MRx. The MRx can be carried in another manner. For example, the MRx shoulder strap or bed rail hook can be used if available on the unit.</li></ol>

<b>ACTIONS PLANNED BY PHILIPS</b>	<p>Philips is initiating a correction to affected devices. A hardware upgrade will be provided free of charge for all units affected by this issue. A Philips Healthcare representative will contact customers with affected devices to arrange for installation of the upgrade.</p>
<b>FURTHER INFORMATION AND SUPPORT</b>	<p>If you need any further information or support concerning this issue, please contact your local Philips representative or the UK Philips Customer Care Service Centre on 0870 532 9741.</p>
