URGENT – Field Safety Notice Philips M1783A and M5526A Sync Cables Electrical Interference Could Pose a Risk for Patients

AFFECTED PRODUCTS	<p>Product: Philips Sync Cables, models M1783A and M5526A</p> <p>Units Affected: All Philips sync cables, models M1783A and M5526A, are affected.</p>
PROBLEM DESCRIPTION	<p>When a Philips monitor/defibrillator is receiving an ECG signal from an auxiliary bedside monitor via a sync cable, the following can occur if the monitor/defibrillator experiences interference from electrical fast transients (EFTs) while connected to AC power:</p> <ul style="list-style-type: none"> • On the HeartStart MRx and HeartStart XL, EFT noise can be misinterpreted as an R-wave • On the HeartStart XL+, EFT noise can disable ECG monitoring, and potentially interrupt demand mode pacing*. <p>*Note: It is contrary to the instructions in the XL+ Instructions for Use (IFU) to perform demand mode pacing while using the sync cable to provide the ECG signal from a bedside monitor. The XL+ IFU includes the following warning: “When pacing in Demand Mode, the ECG cable from the patient must be directly connected to the HeartStart XL+.” If the user follows this warning, this pro

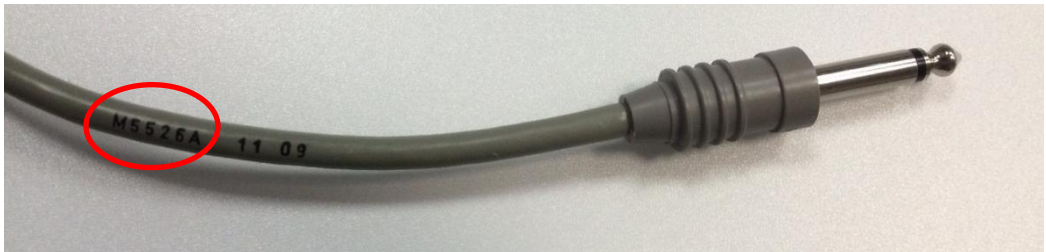
HAZARD INVOLVED	<p>When using a sync cable with the HeartStart MRx or HeartStart XL, EFT noise can be mistaken as an R-wave. If this occurs when performing synchronized cardioversion, there is a potential for inducing ventricular fibrillation if shocks are synchronized to EFT noise instead of the patient’s actual R-wave.</p> <p>When using a sync cable with the HeartStart XL+, EFT noise can disable ECG monitoring, and potentially interrupt demand mode pacing, leading to a possible delay in therapy. A power cycle is required to resume ECG monitoring. (Note: fixed mode pacing is not impacted by this issue.)</p>
HOW TO IDENTIFY AFFECTED PRODUCTS	<p>Philips M1783A and M5526A sync cables identified above are affected by this issue.</p> <p>The model number is printed on the outside of the cable, near the end with the ¼” phone plug, as shown below:</p>

ACTION TO BE TAKEN BY CUSTOMER / USER	<p>Prior to receiving a replacement sync cable, you can continue to use affected sync cables, provided that they are only used to connect the ECG Out jack on the monitor/defibrillator to the ECG (input) port on a bedside monitor. The issues described in this letter do not impact this application of the sync cable.</p> <p>Affected sync cables should not be used to connect the ECG Out jack of a bedside monitor to the ECG (input) port on the monitor/defibrillator.</p>
ACTIONS PLANNED BY PHILIPS	<p>Philips will replace all affected sync cables with a new sync cable free of charge. A Philips Healthcare representative will contact customers with affected devices to arrange for your replacement.</p>
FURTHER INFORMATION AND SUPPORT	<p>If you need any further information or support concerning this issue, please contact your local Philips representative or the UK Philips Customer Care Service Centre on 0870 532 9741.</p>
