Ortho Clinical Diagnostics	<p style="color: red; margin: 0;">URGENT FIELD SAFETY NOTICE</p> <p style="margin: 0;">Potential Sample Metering Anomaly on VITROS® Systems using Software Version 3.2.2 and Below</p> <p style="color: red; margin: 0;">Immediate Action Required</p>
----------------------------	---

Affected Products

Product Name	Product Code	Affected Software Versions	Unique Device Identifier No.
VITROS® 3600 Immunodiagnosics System	6802783 6802914 (Refurbished)	Software Version 3.2.2 & Below	10758750002979 10758750007103
VITROS® 5600 Integrated System	6802413 6802915 (Refurbished)		10758750002740 10758750007110

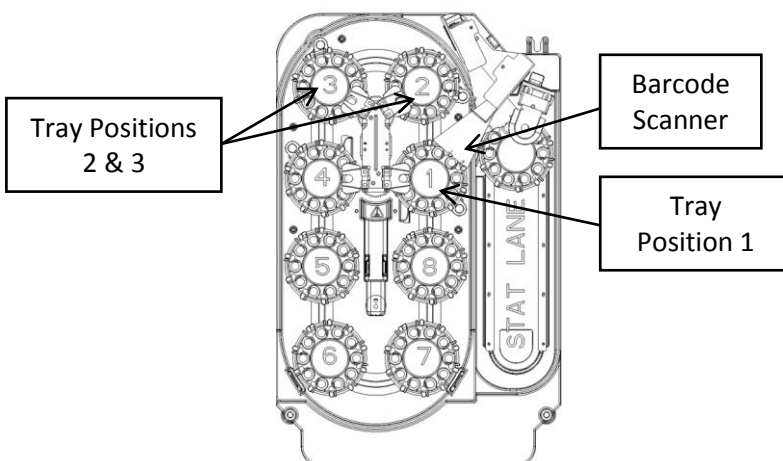
Located within the Sample Supply, there are 4 sampling positions in the Routine Lane. The following *specific* sequence of events must occur in order for the software timing anomaly to happen:

The affected positions located in the Routine Lane of the Sample Supply as shown below:
