URGENT Field Safety Notice: RA 2017-039

FSCA Identifier: Product Field Action RA 2017-039

Catalog #	Manufacturer Part Name	Lot #
33625110	Standard Lag Screw Omega 110mm Length	V06279
33625105	Standard Lag Screw Omega 105mm Length	V06269

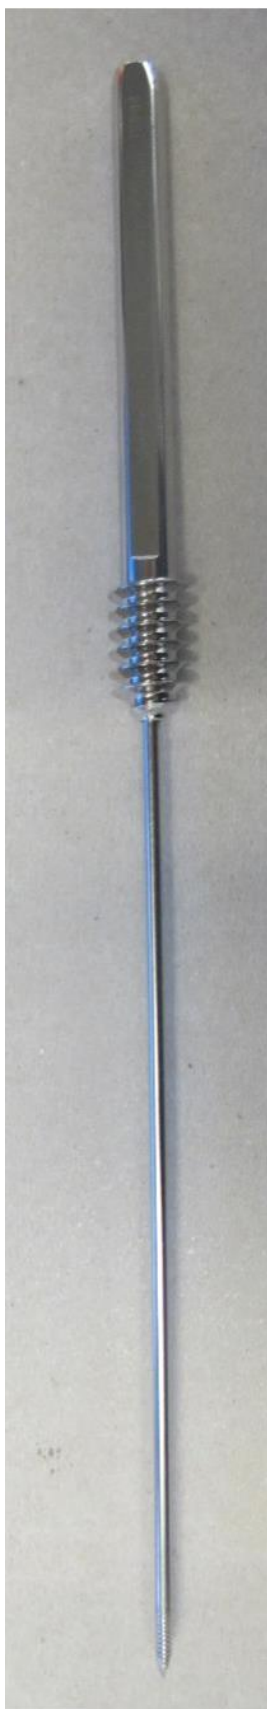
Stryker received a complaint from the field regarding a Standard Lag Screw Omega 110mm LENGTH (Cat# 33625110 & Lot# V06279). The end customer reported via sales rep, that the lag screw was not completely cannulated and the guide wire could not go through the cannula of the screw. No harm reported.

The investigation revealed that the obstruction is related to a metal burr in the cannula of the screw which was not removed during manufacturing. The nonconformance is limited to 2 batches.

Figure 1: Affected screw with guide wire.

Recall of subject devices.

1. Immediately check your internal inventory and quarantine all subject devices pending to return to Stryker.
2. Circulate this Field Safety Notice internally to all interested/affected parties.
