Urgent Product Correction Notice – FSCA 3445

VITEK® 2 Identification / Antimicrobial Susceptibility Test Cards referenced in Appendix A

**URGENT PRODUCT CORRECTION NOTICE –
FSCA - 3445 – VITEK® 2 - Card Pouch Integrity**

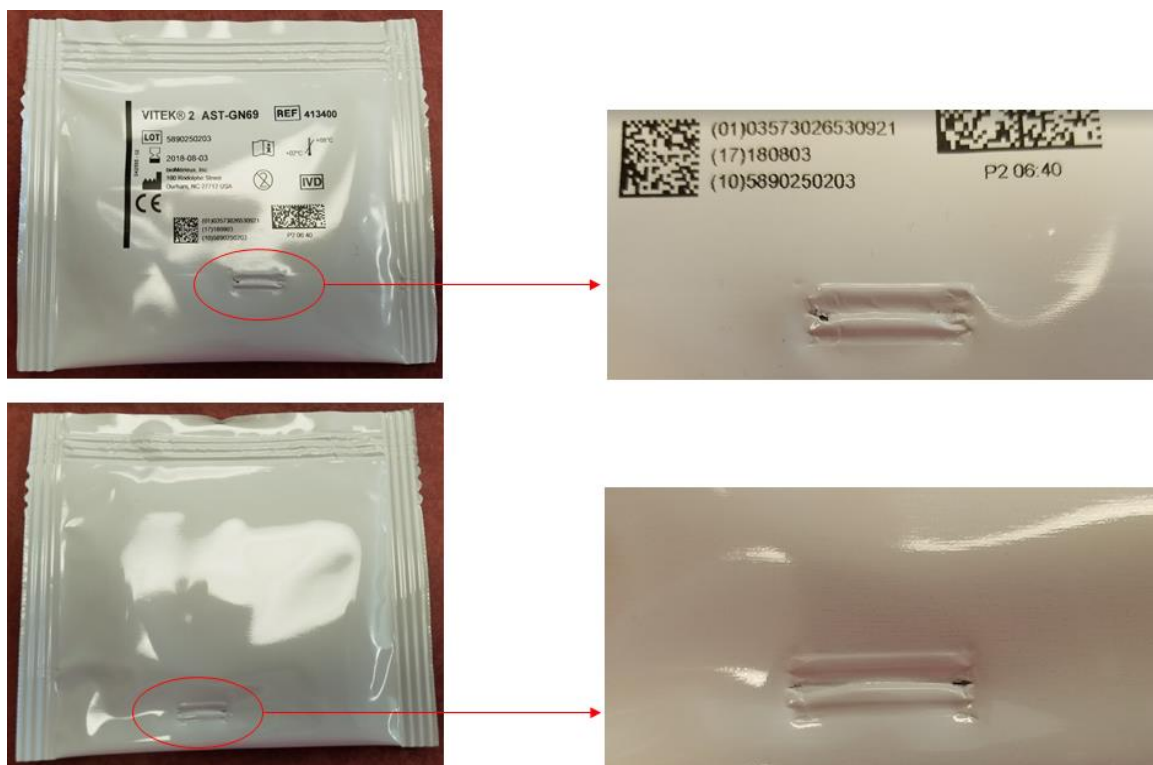
Figure A - Example of Pouch Defect

A potential issue was identified related to the white pouch which contains VITEK® 2 test cards for the product lots specified in Appendix A. bioMérieux has determined that the integrity of some of the VITEK® 2 test card pouches may be compromised. Based on our investigation, a compromised test card pouch can impact card reagents due to the entry of moisture.

The white pouch is composed of five (5) layers of material, four (4) of which are clear. All five layers must be compromised for a pouch to potentially allow moisture to enter the pouch. Upon visual inspection of the pouch, you may notice a small puncture or tear in the packaging at the "stitch seal" (**see Figure A immediately below**). Per product labeling, do not use the card if the pouch (the white protective package cover) is damaged. Based on internal testing, approximately 20% of card pouches exhibited a visual defect; the majority of card pouches with this visual defect maintained pouch integrity, i.e. at least one of the five material layers remained intact. However, 1 in 200 (0.5%) card pouches that passed careful visual inspection failed further integrity tests, indicating the potential for entry of moisture.

1. Check the lot numbers in your inventory against the lot numbers listed in Appendix A.
 2. For impacted lots, visually inspect the test card pouches on both sides for the defect.

- a. If the defect is observed, destroy the associated test card(s) and contact our Technical Service Department on 0044 (0) 1256 480711 or email uktechnical@biomerieux.com for credit.
