Field Safety Notice

FSCA Identifier FSN20180300_

Affected Devices NovaLine® Tubing Sets for Hemodialysis

Date 27 March 2018

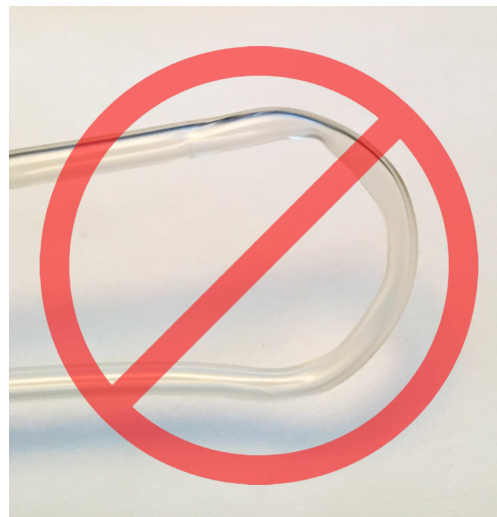
Problems 2 Description An exceptionally rare event of kinking of the blood pump segment

Cause: This might be caused by the worker's improper tubing placing and the inspector fails to pick it out during 100% final product inspection and sampling inspection.

Potential Risk: Hemolysis

Action to be Taken by Customers / Users Operator must check the presence of kinking all along the bloodline before use. In case the operator recognizes the presence of kinking, the tubings must be scrapped.

Actions Planned by Vital Healthcare Re-train the workers on tubing rolling process as well as workers on 100% final inspection of finished products

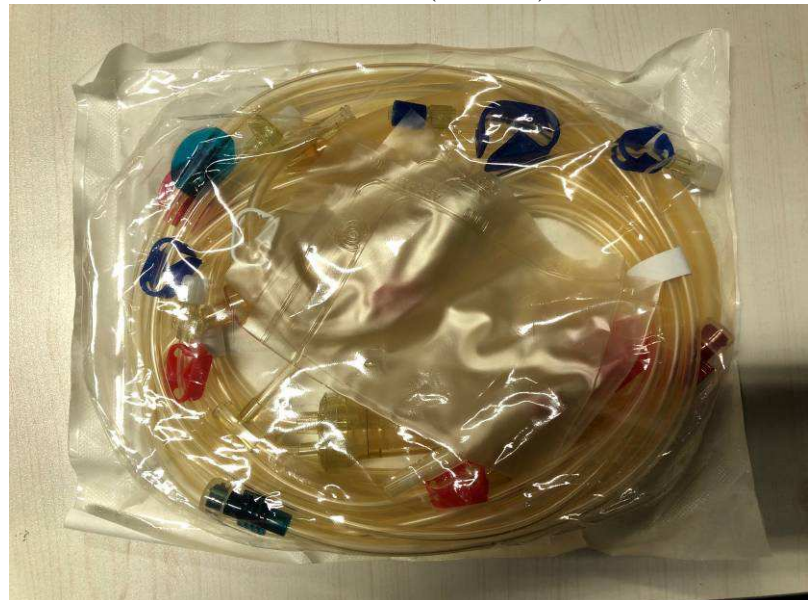
Problems 3 Description Some events of loose component inside primary packaging such as detached drainage bag and detached Transducer Protector (TP)

Cause: Improper operation of the worker. Components may not be tightly screwed during production and become loose after long time transportation.

Potential Risk: Contamination / Infection / Clotting

Action to be Taken by Customers / Users Operator must check the presence of detached components before open the primary packaging and take care during packaging opening that no loose components fall on contaminated surfaces (i.e floor).

- If loose components fall onto the floor they must be scrapped and a entire new bloodline must be used.
- If detached bags or TP are found inside primary packaging it could be easily reconnected.

Actions Planned by Vital Healthcare Retrain the workers. Increase the sampling amount for inspection.

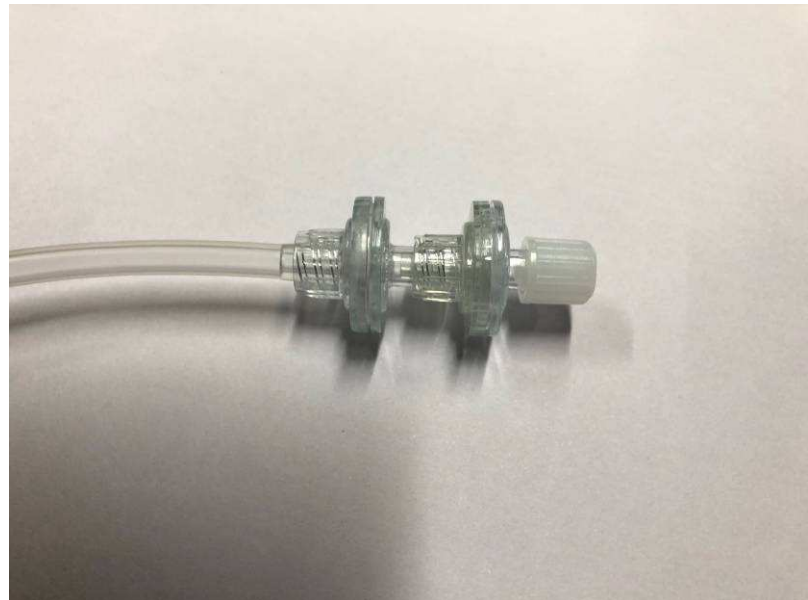
Problems 4 Description Rare events of air entrance in the extracorporeal blood circuit. Majority parts of the events involve the transducer protector. The first TP was glued to the tubing and the second TP was screwed to the first TP manually. The second TP might not be firmly connected.

Cause: Improper operation of the worker. Components may not be tightly screwed during production and become loose after transportation. If the connection is not tightened by operator according to section 5.4 of the manual, air entrance may occur.

Potential Risk: Clotting

Action to be Taken by Customers / Users Operator must check the tightening of all the bloodlines connection before use according to section 5.4 of relevant product *Instructions for Use*. The critical connection to check is illustrated below:

Actions Planned by Vital Healthcare The double TP should be glued to ensure they're leak-proof and reduce the risk
