URGENT - FIELD SAFETY NOTICE

IntelliVue MX40

Increased Battery Power Consumption and Absence of Low Battery Alerts

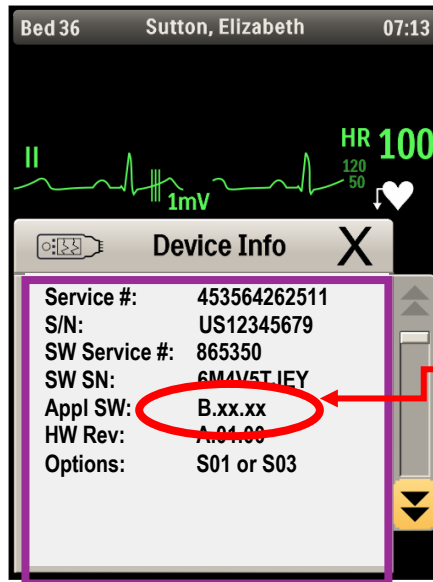
Device Info Screen

Revision B software

Confirm Revision B software

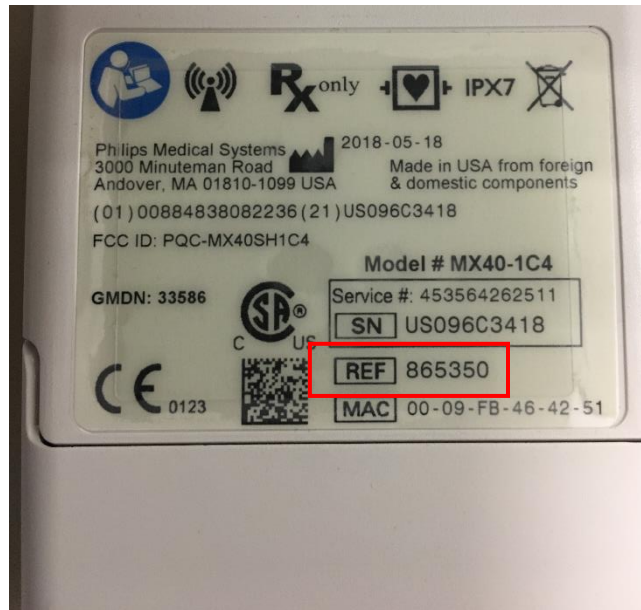
Problem 2 / Step 1

Confirm 865350 or 865351 part number ("REF")

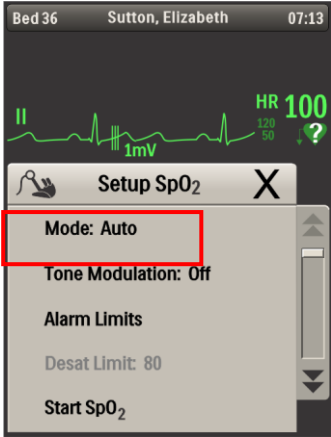
<p>Problem 2 / Step 3 Confirm that MX40 includes SpO₂ operating in automatic mode</p>

<p>ACTION TO BE TAKEN BY CUSTOMER / USER</p>	<p>MX40 monitors can continue to be used while awaiting a software upgrade.</p> <p>Customers should maintain an adequate supply of fully charged batteries given the approximately 25% increased power consumption.</p> <p>Switch to continuous or manual SpO₂ measurements if your unit is using automatic measurement mode.</p>
<p>ACTIONS PLANNED BY PHILIPS</p>	<p>Philips Healthcare will release a software revision, which will correct both issues. Philips will contact you to arrange for software correction.</p>
<p>FURTHER INFORMATION AND SUPPORT</p>	<p>If you need any further information or support concerning this issue, please contact your local Philips Representative at or the UK Philips Customer Care Service Centre on 0870 532 9741.</p>
