Urgent Field Safety Notice

GD4500 Rev B

Getinge is initiating a field safety correction with regards to Washer-Disinfector of GETINGE Getinge 46-Series (46T excluded) with PACS 300/350 control.

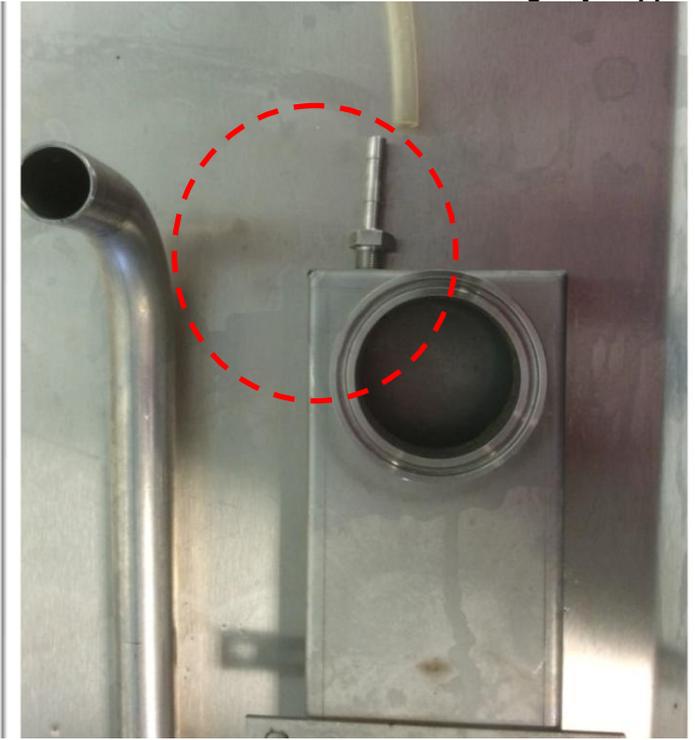
We have however now after performing detailed root cause analysis identified the problem as insufficient water flow throughout the manifold due to formation of air-pockets where sedimentation may occur. Use of detergents that are not recommended might also have negative impact.

Figure 1: vent hole added on top of manifold to prevent trapping of air.

- Cleaning of the manifolds.
- Adding ventilation-hole at the top of the manifold and linking it to the chamber i.e. preventing the formation of any air-pockets and secure a continuous water flow. See details in appendix 1
- Getinge will amend the instruction for use regarding the use of detergents, including a list of recommended detergents.

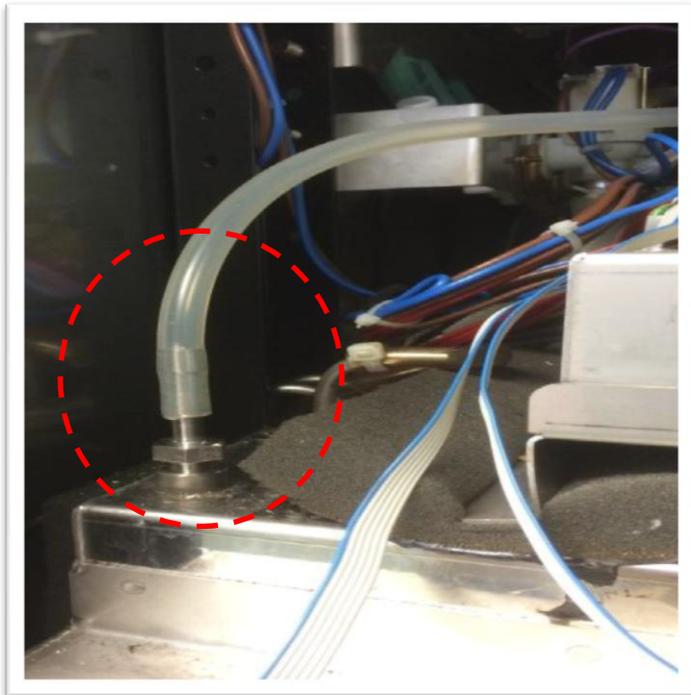
Figure 2: The vent hole is linked back to the chamber through a pipe
