FA-Q122-CRM-2 URGENT Field Safety Notice

FOR A SUBSET OF GALLANT™, NEUTRINO™ NxT,
AND ENTRANT™ ICDs AND CRT-Ds
MANUFACTURED PRIOR TO APRIL 2022
MODELS CDVRA500Q, CDDRA500Q, CDHFA500Q, CDVRA600Q,
CDDRA600Q, CDHFA600Q, CDVRA300Q, CDDRA300Q, AND CDHFA300Q

August 2023

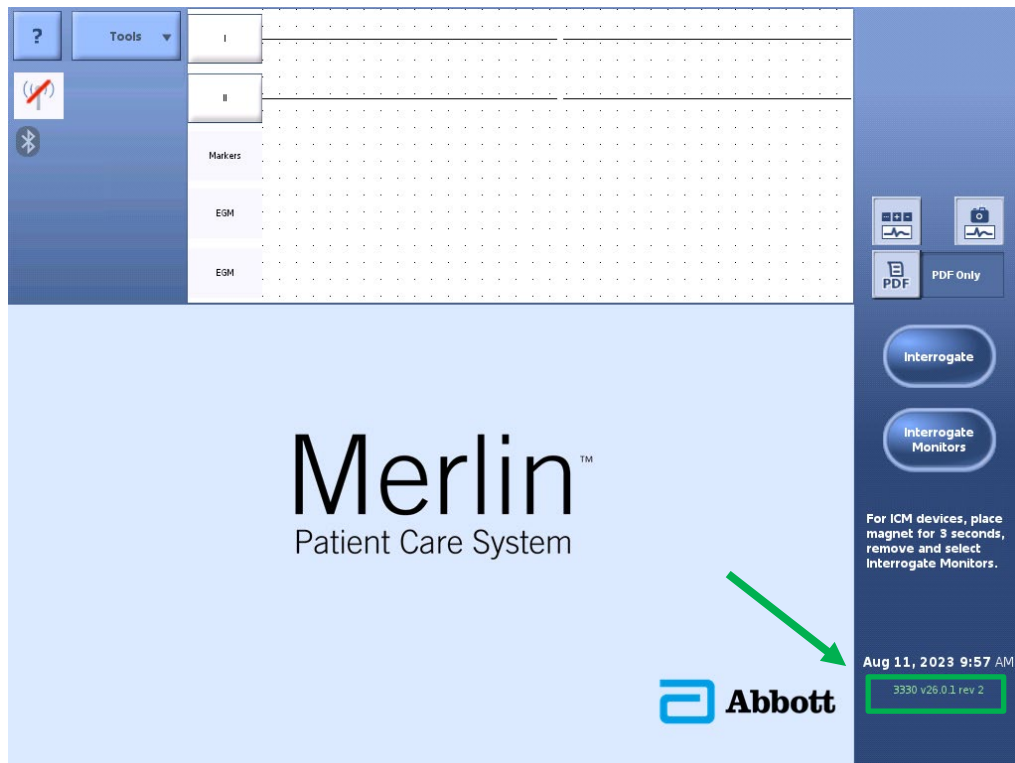
Image 2: Merlin™ PCS 3650 software version visible on the startup screen

The Merlin™ PCS 3650 software version is visible on the lower right corner of the initial startup screen, as displayed in the image below. Confirm the programmer software version is 3330 v25.8.2. rev. 1 or higher.
