URGENT Field Safety Notice

Allura Xper, Allura Centron, and Azurion systems
Potential loss of imaging functionality resulting from no or intermittent X-ray radiation initiation through the wired foot switch.

27-October-2023

Reference: 2023-IGT-BST-004: Allura Xper, Allura Centron, and Azurion Systems.

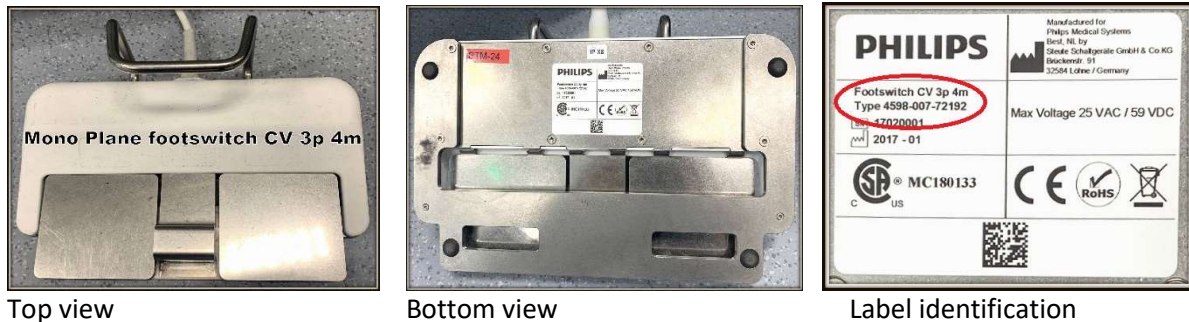
The reference/type of the wired foot switch can be found on the label located on the bottom of the wired foot switch, as shown in Figure 1.

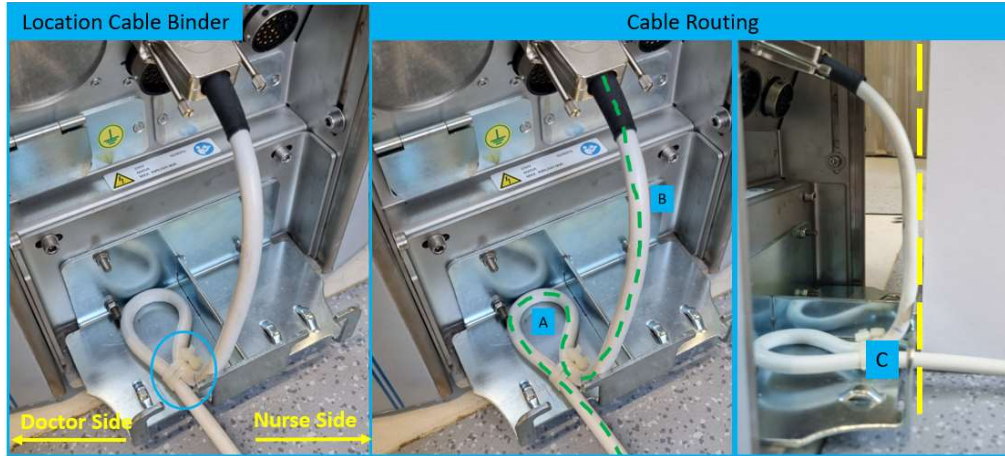
Figure 1: AD7XT and AD7XNT Patient Table

- Cable binder used for strain relief:
 - Type of cable binder(s)
 - Number of cable binder(s)
 - Position of cable binder(s)
- Cable routing (depending on picture indicated with "A" "B" "C")
- For AD7NT, there are 2 possibilities for strain relief:
 - Strain relief by means of bushing (Figure 4a)
 - Strain relief by cable binder (Figure 4b)
- For correct routing and strain relief, see Figures 1-6 below.

Number of cable binder(s): 2 (two)

If strain relief or routing is not correct, repair according to the repair instructions.

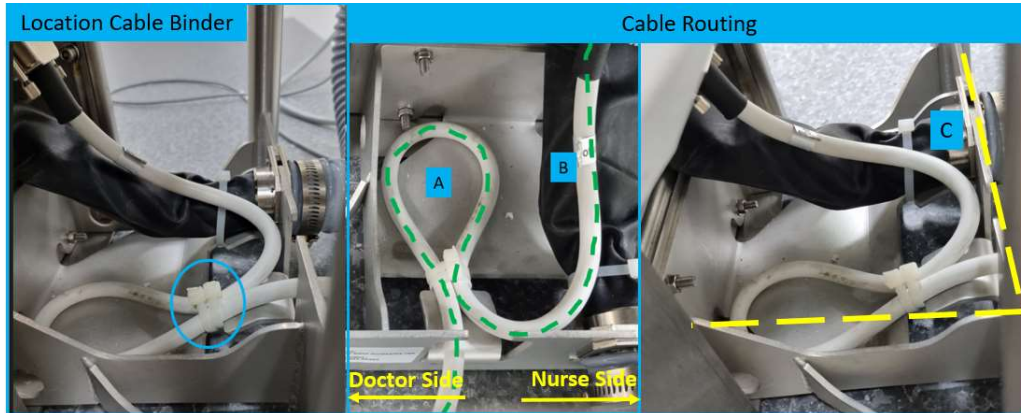
Figure 2: AD7XT and AD7XNT Auxiliary OP Rail Patient Table Strain Relief

Number of cable binder(s): 2 (two)

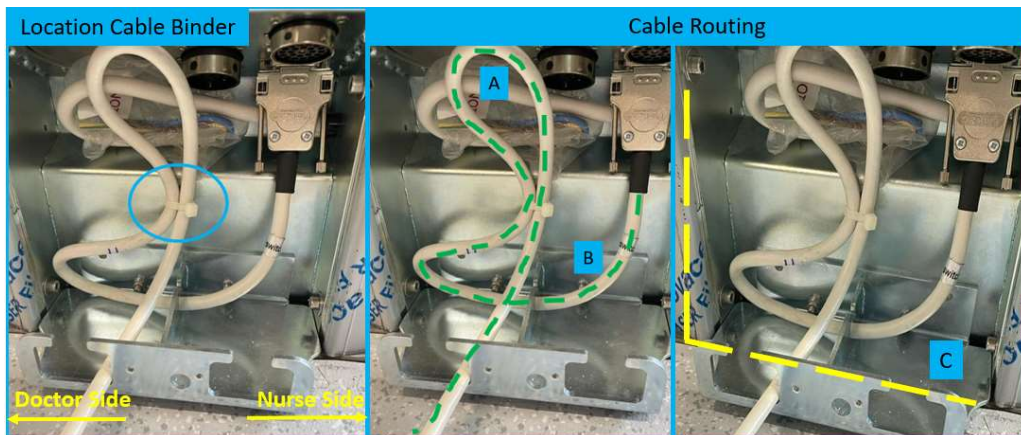
Figure 3: AD7 Patient Table

Number of cable binder(s): 1 (one)

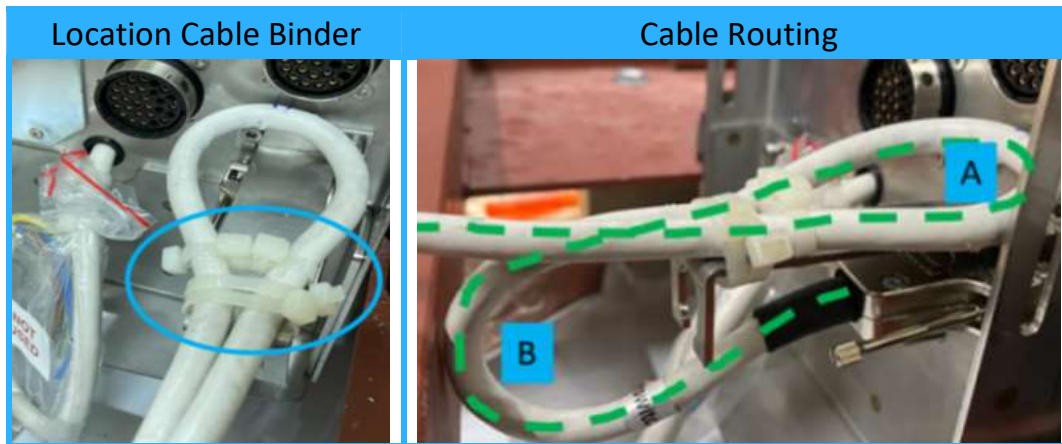
Figure 4b: AD7NT Patient Table with cable tie strain relief

Number of cable binder(s): 5 (five)

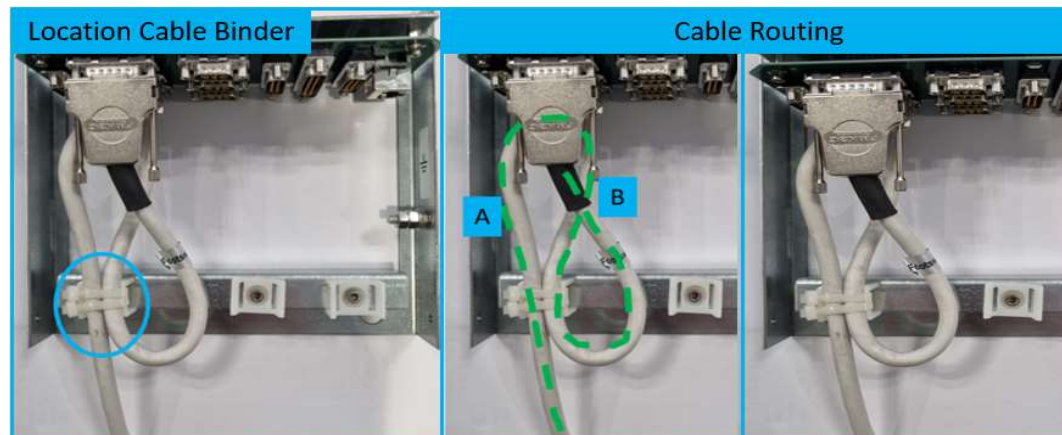
Figure 5: Pedestal Wall Connection Box

Number of cable binder(s): 2 (two)

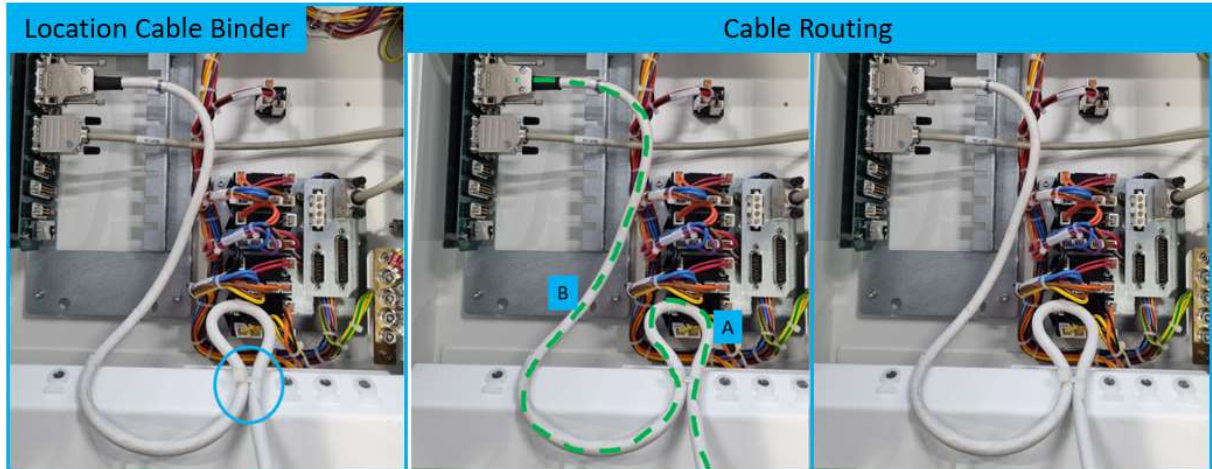
Figure 6: Surgery Wall Connection Box

Number of cable binder(s): 1 (one)

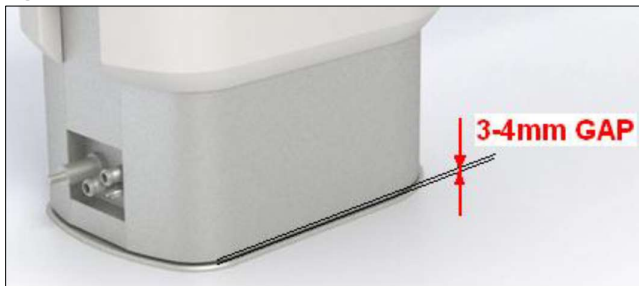
Figure 7: Non-swivel table (AD7NT, AD7XT and AD7XNT)

- For a non-swivel table
 - Make sure that the clearance to the fluid protection plate is 3-4 mm
 - Refer to Figure 7
- For a swivel table
 - Make sure that the clearance to the swivel cover is 3-4 mm
 - Refer to Figure 8

If the gap between the plinth covers and the floor does not satisfy the above requirement, adjust the plinth cover according to the repair instructions.
