URGENT Field Safety Notice

MD Eleva systems
Potential loss of imaging functionality resulting from no or intermittent X-ray radiation initiation through the wired foot switch

27-October-2023

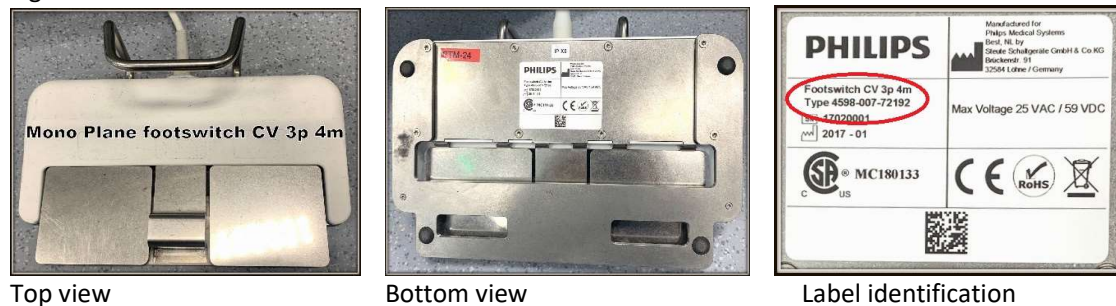
The reference/type of the wired foot switch can be found on the label located on the bottom of the wired foot switch, as shown in Figure 1.
