To affected users of Siemens Healthineers
MAGNETOM
 Free.Max/Free.Star/Amira/Sempra/Mica/Spectra

Customer Safety Advisory Notice MR078/23/S

SAFETY ADVISORY NOTICE

Customer Information about possible artifacts from over-ear headphones during head examinations

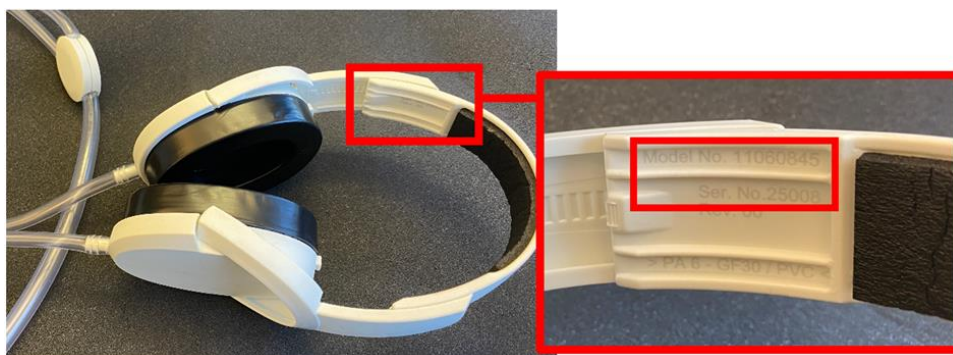
Figure 1: Location of model number and serial number on over-ear headphones

- Check the model number and serial number of your over-ear headphones. See *Figure 1* for their location on the over-ear headphones. If the model number is not identical or the serial number is outside the stated range (7981 – 32200), they are not affected.

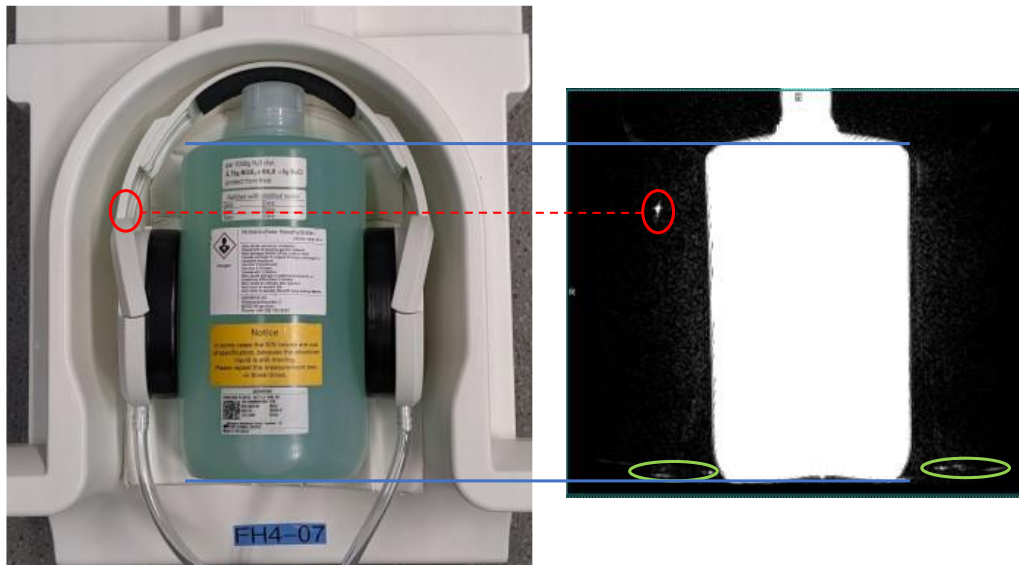
Figure 2

Left side: correct setup of phantom bottle and headphones in head coil

Right side: Example of signal from lubricating grease can be seen outside the phantom, marked with a red circle. The artifacts must be on the same height as the potential affected headbands of the headphone.

Please note: MR imaging often shows artifacts with phantom bottles in this extreme windowing e.g. at the top and/or bottom of the phantom. These artifacts are marked with green circles in the above example and can be ignored.

- **If no artifacts are visible** during the described phantom measurements, your over-ear headphones are not affected and can continue to be used for MRI head examinations.

- **If artifacts are visible** during the described phantom measurements, your over-ear headphones are affected and must not be used for head examinations. In this case, please use the built-in loudspeaker in the scanner for patient communication or, if available, in-ear headphones which are also not affected by the described issue.

Siemens Healthineers will correct the issue by exchanging the headband of the affected over-ear headphones at customer sites with the field update MR073/23/S. This replacement program will start in October 2023. With the exchange of the headband the root cause is eliminated.
