Urgent Field Safety Notice

Claria MRI™ CRT-D SureScan™ and Amplia MRI™ CRT-D SureScan™

Patient Management Recommendations

Medtronic reference: FA747

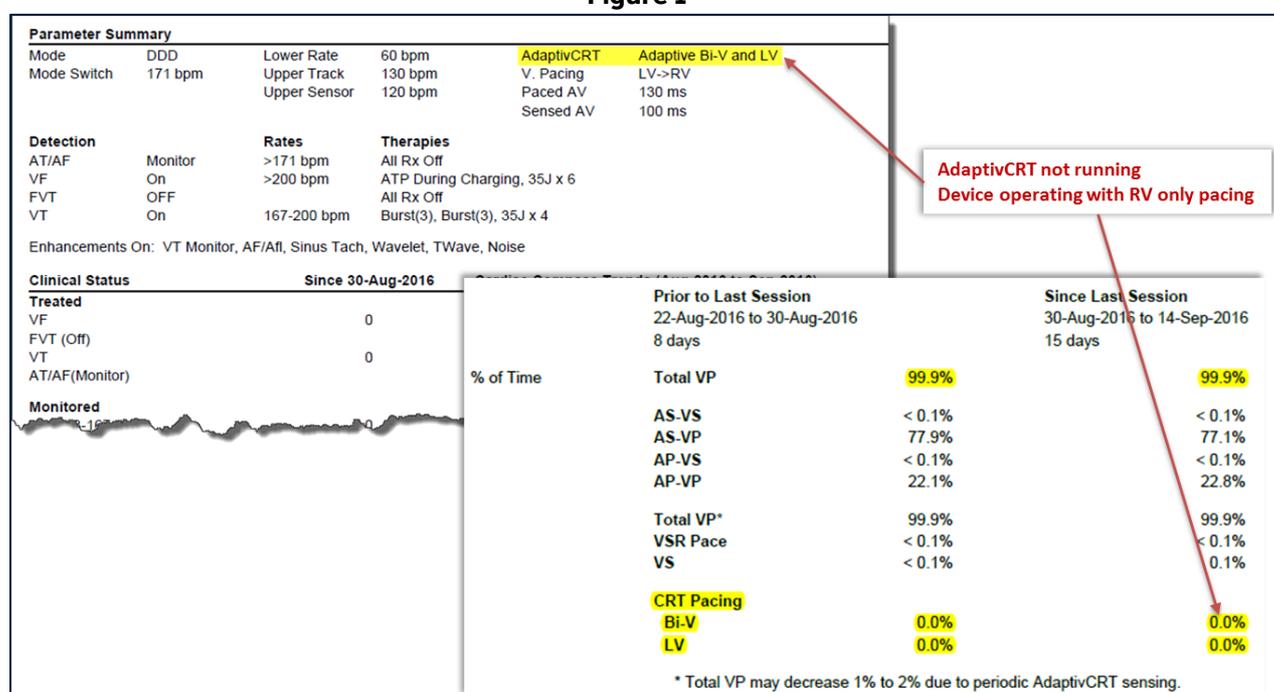
Figure 1

When a patient with AdaptivCRT enabled (shipped setting) is subsequently programmed to MVP mode and then re-programmed back to DDD or DDDR, AdaptivCRT is not re-enabled. When this programming sequence occurs, LV pacing is not delivered, despite parameters indicating AdaptivCRT is enabled (Appendix B, Figure 1). This will result in RV only pacing which may be undesirable for the patient. LV pacing will remain disabled until a specific programming sequence is manually completed; refer to the Patient Management section of this letter (Appendix B) for details.

- If the CRT setting is currently programmed to *Adaptive Bi-V and LV* or *Adaptive Bi-V* (Figure 1), review rate histogram CRT Pacing percentages (CRT Pacing: Bi-V and LV).
- If Bi-V and LV pacing percentages *Since Last Session* are both near 0%, then the device has encountered the programming sequence and has lost LV pacing; proceed to step 2.

- Select the CRT parameter window, select *Nonadaptive CRT*, and select *PROGRAM*.
- Select the CRT parameter window, select the desired AdaptivCRT setting (*Adaptive Bi-V and LV* or *Adaptive Bi-V*), and select *PROGRAM*.
