Urgent Field Safety Notice

Affected Product: TAYLOR SPATIAL FRAME[®] WEBSITE SOFTWARE
FSCA reference: R-2017-40
Date: December 13, 2017
FSCA action: Advisory Notice
Details of affected product: See below

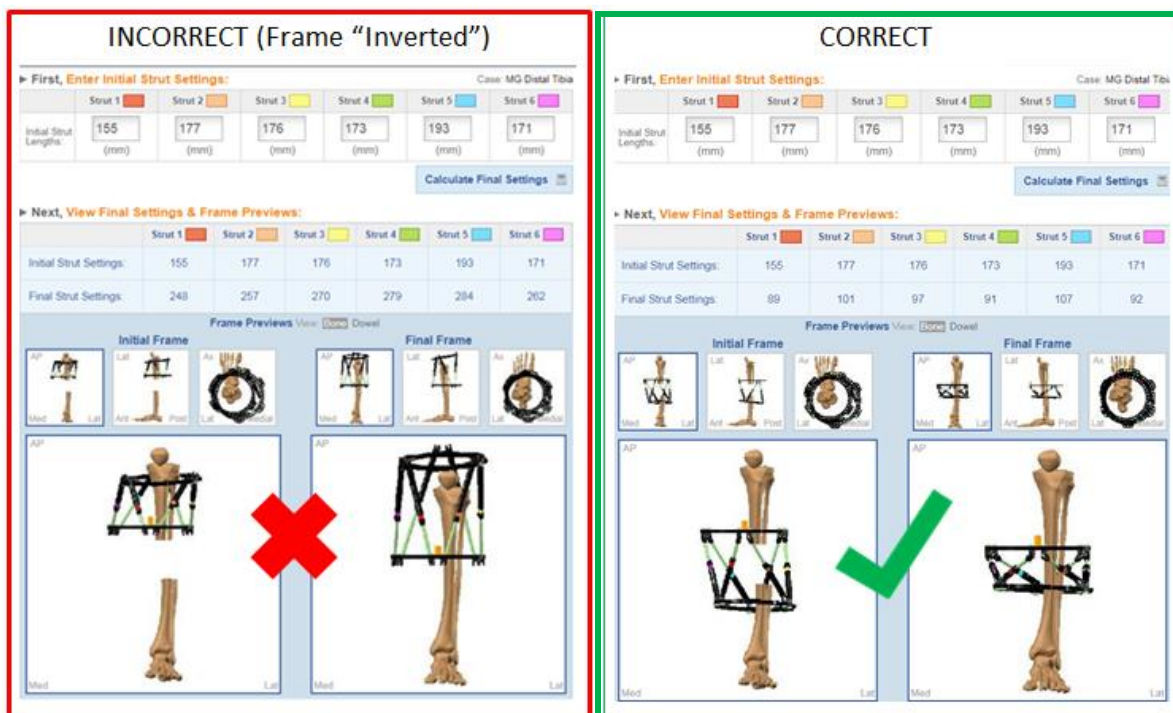
This letter is to inform you that Smith & Nephew, Inc. has initiated a voluntary Field Safety Corrective Action (FSCA) to notify users of a potential SpatialFrame.com website software issue. We became aware that in rare circumstances, when surgeons use the software to plan the strut adjustment, an “inverted” image of the frame is generated by the software. This situation is easily recognizable; the frame will appear “inverted” in the preview images on the Strut Settings tab (see below). If the surgeon proceeds to print the patient prescription on the basis of the “inverted” frame, the strut adjustments on the prescription will be incorrect. An example of an inverted image is provided below.

In the event that a case with an inverted frame strut adjustment schedule was provided to the patient, the patient would be following incorrect instructions resulting in unanticipated movement of the bone segments. In one reported instance, this resulted in preconsolidation of the osteotomy which required surgical intervention.

This situation has a very low occurrence rate (0.005%) and Smith & Nephew is currently working to implement corrective measures to the software to resolve this issue. We are requesting that surgeons systematically verify images generated by the SpatialFrame.com software to confirm that all frame preview graphics match the frame on the patient clinically before providing a strut adjustment schedule to the patient.

In the unlikely event that you notice an inverted frame in the software, you should repeat the process for the same case and notify a Smith & Nephew representative.
