Ref. Spiegelberg	Ref. BfArM
CMP-202211001	Fall-Nr. 31936/22

## Urgent Field Safety Notice

For Spiegelberg Probes with tunneling:

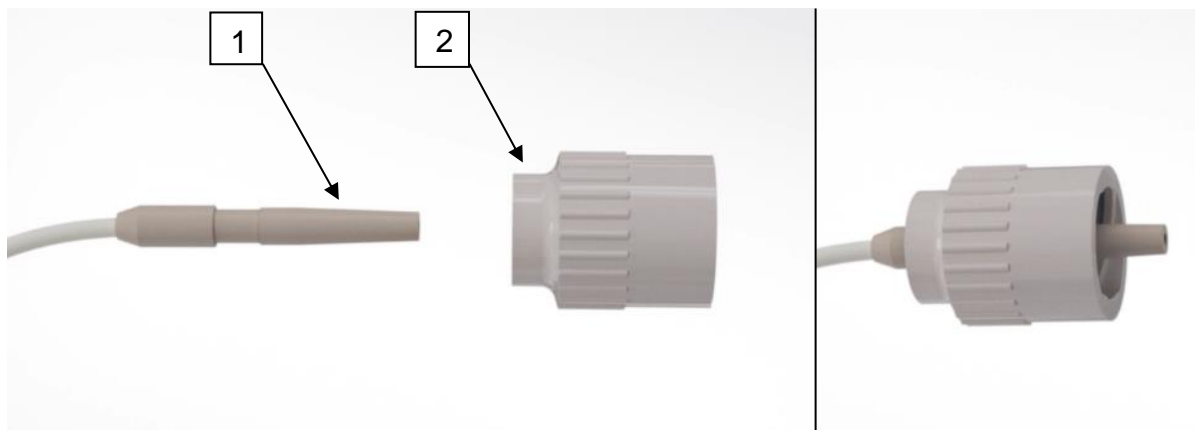
To connect the extension tube, a securing nut (see Figure 1, (2)) is pushed on the probeside-connector (see Figure 1, (1)). The securing nut contains two plates that allow the probeside-connector to snap securely in place inside the securing nut.

Figure 1: left: probeside-connector (1) and securing nut (2); right: finished connection

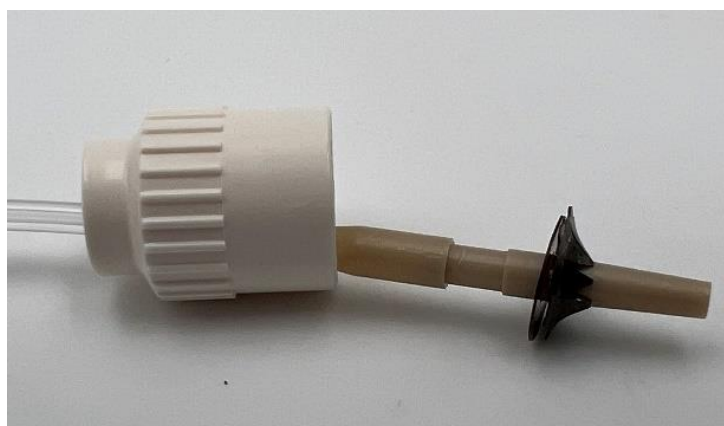
Due to a slowly progressed joining-tool wear, it is possible that the two plates inside the securing nut might break free of the securing nut (see Figure 2).

Figure 2: Failed connection

1. The probe is placed and tunneled. The user tries to make the connection between the securing nut and the probeside-connector. The connection fails (as shown in Figure 2) and cannot be made. The two plates and the securing nut can be removed from the probeside-connector, a new securing nut needs to be used. Therefore, a new product needs to be opened.
2. The probe is placed and tunneled. The user tries to make the connection between the securing nut and the probeside-connector. The connection fails (as shown in Figure 2) and cannot be made. The two plates and securing nut cannot be removed from the probeside-connector, the probe needs to be removed and a new probe must be placed and tunneled.

Upon investigation, it was found that a slowly progressed joining-tool wear, that was not identified within the maintenance process, caused the weakening of the securing nut.

- a. Update of the manufacturing process, tools, and standard operating procedures.
- b. Update of the concerning tool-maintenance process.
- c. Update of the risk assessment.

In order to mitigate the potential risk for the patient, Spiegelberg will provide double packed and sterile security nuts as replacement parts. These security nuts will originate from the updated manufacturing process.
