URGENT Field Safety Notice

BrightView, BrightView X, BrightView XCT
Patient Extremity Entrapment Hazard while using Pre-Programmed Motion

December 21, 2023

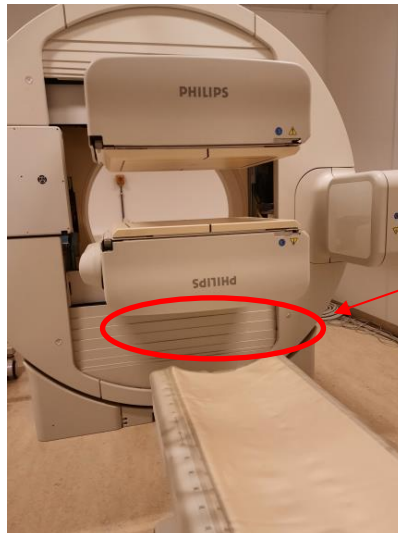
Figure 1. Image of gap between the patient support and detector

While using Pre-Programmed Motion (PPM) in a non-clinical or quality control manner, a gap can be created between the patient support and the detector, which presents a potential hazard. The gap can occur if the External QA PPM is executed and the lower detector is raised up and the patient table is lowered, both using the hand controller. This gap presents a potential extremity entrapment hazard for patients while the system detectors and patient support are in motion.

Gap between the detector and patient support. During PPM, the gap may decrease creating the potential for extremity entrapment.

Philips is working to provide a solution to remove this potential hazard identified with the use of the PPM. In the interim, initiate the "Patient Loading PPM" without the patient on the imaging table, prior to use and proceed in accordance with the guidance of the system warning as shown in Figure 4 and refer to the Instruction For Use guidance outlined below.
