URGENT Field Safety Notice

Philips **Azurion System** R1.0, R1.1, R1.2, R2.0, R2.1, and R2.2
Potential loss of imaging functionality and clinical data stored in the system

08-DEC-2023

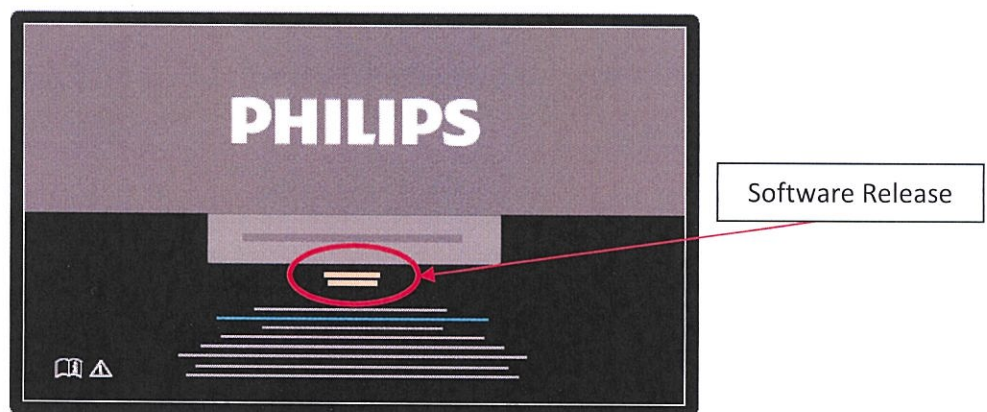
Figure 2: System start-up screen

The software version of the Philips Azurion system can be identified during start-up (Figure2).
