URGENT Field Safety Notice

BrightView, BrightView X, BrightView XCT (Product Codes 882480, 882478, 882482)
Potential Detector Fall could Result in Injury to the Patient

December 14, 2023

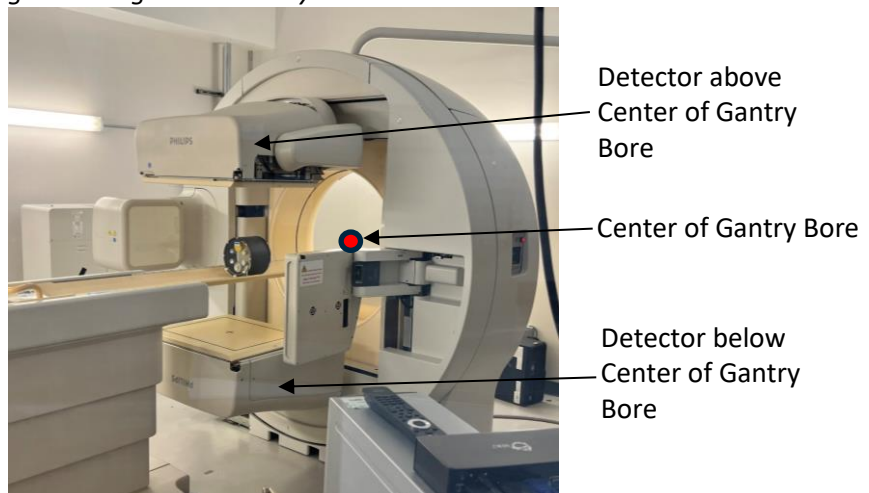
Figure 1. BrightView XCT system detector location

- **Scenario 1:** If the detector is below the center of the gantry bore and the detector support component fails, the detector may descend downward unexpectedly and potentially contact the patient.
- **Scenario 2:** If the detector is above the center of the gantry bore and the detector support component fails, the detector will not be able to move to complete the imaging.

Refer to Figure 1 for the location of detectors relative to the gantry bore.

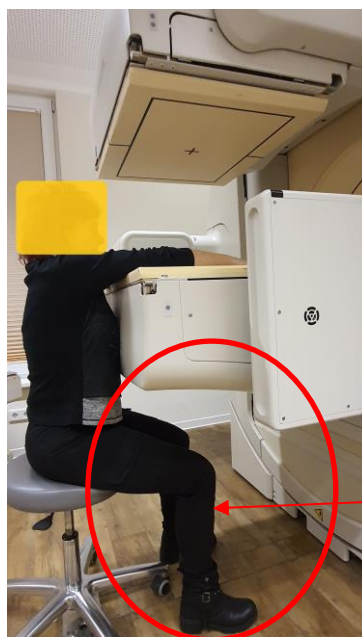
Figure 3. Avoid positioning a patient's lower limbs under the detector below Center of Gantry

Scenario 1, Detector positioned below center of gantry: If the patient’s lower limb(s) is directly below the lower detector and the support component fails, the detector may descend downward in an uncontrolled manner and contact the patient. There is a potential for abrasion, contusion, laceration, and/or fracture to the patient’s lower limb(s). Additionally, there will be an interruption to normal system operation. A rescan or re-injection of radiopharmaceutical to the patient may be required.

Do not position a patient's lower limbs under the lower detector

- **Do Not** position a patient's lower limbs directly under the detector below the Center of Gantry bore (refer to Figure 3), for example while performing dual head (DH) hand (left/right) procedure.

Philips will contact you to schedule a time for a Philips Field Service Engineer (FSE) to visit your site and to inspect and correct the system if necessary (FCO 88200538).
