## **URGENT – Field Safety Notice**

### **Philips IntelliVue Information Center (PIIC) iX**

**SpO2 and/or Non Invasive Blood Pressure (NBP) alarms may become disabled without visual notification to the user**

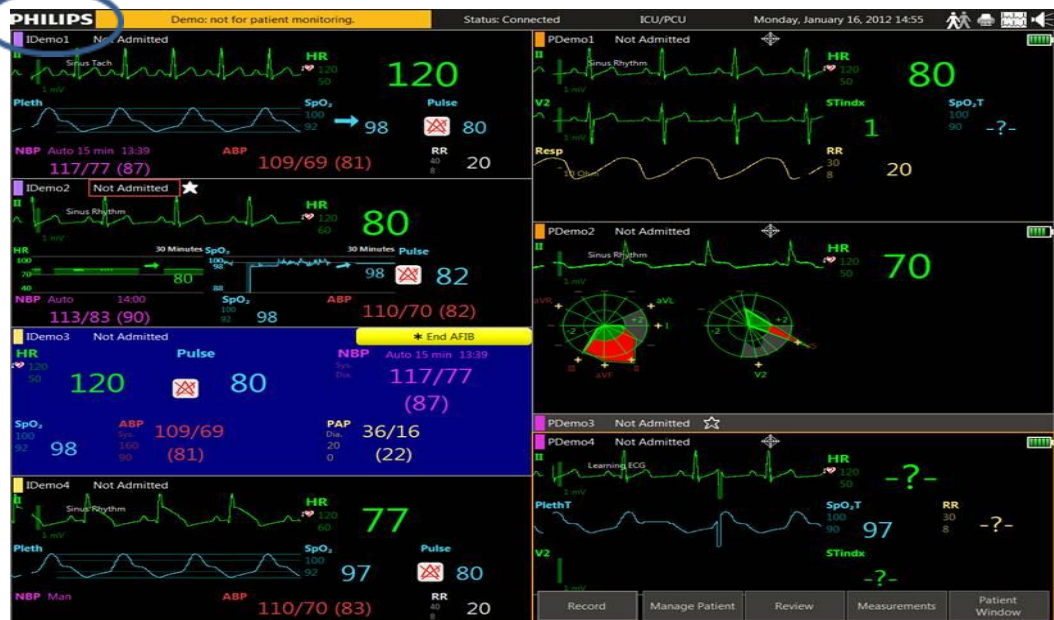
**Figure 1 - Location of the Philips watermark**

PIIC iX Revision A.XX – Identify the affected product by clicking on the Philips watermark on the PIIC iX surveillance display. See Figure 1. This will bring up the Product Support Page. Software Version has the release that the product is running. See Figure 2
