FSN # 72800614, Revised

**URGENT – Field Safety Notice  
Medical Device Correction**

**Brilliance CT series (6, 10, 16, 16 Power, 40, 64, Big Bore, iCT, iCT SP),  
Ingenuity CT, Ingenuity Core, Ingenuity Core<sup>128</sup>, Ingenuity Flex, and  
MX8000 Dual v. EXP**

**Unintended Horizontal Patient Support / Couch Motion Correction and  
Service Labeling Update Due to Unlocked Service Latch**

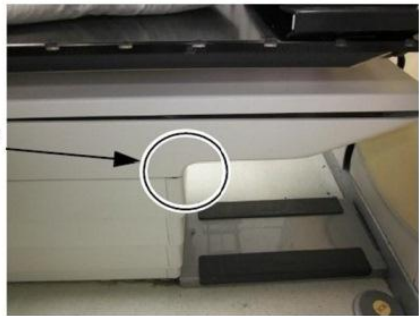
<p><b>PROBLEM DESCRIPTION</b></p>	<p>We have found, if the service latch is not properly secured during servicing of the device, the table top's subframe becomes free floating causing unintended, horizontal motion.</p> <p>To date, there have been no reported injuries or deaths resulting from this issue.</p> <p style="text-align: center;"><b>Subframe Patient Support Cover Alignment: Engaged Versus Disengaged</b></p> <div style="display: flex; justify-content: space-around;"> <div style="text-align: center;">

<p>Subframe Patient Support Engaged, with Covers Aligned</p> <p><b>Figure 1</b></p> </div> <div style="text-align: center;">

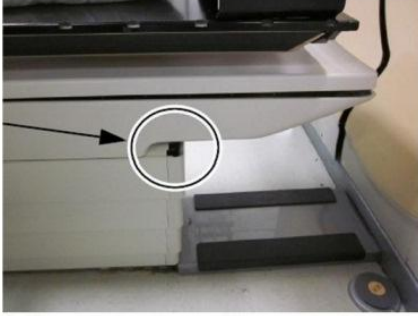
<p>Subframe Patient Support Disengaged, with Covers Misaligned</p> <p><b>Figure 2</b></p> </div> </div>
<p><b>HAZARD INVOLVED</b></p>	<p>There is a risk of serious injury to the patient and Operator/Technician as a result of the patient support / couch subframe free floating.</p> <p>For the patient:</p> <ul style="list-style-type: none"> <li>• There is a potential for disconnection or movement of invasive medical devices such as I.V.'s, tracheostomies, and surgical drains</li> </ul> <p>For the Operator/Technician:</p> <ul style="list-style-type: none"> <li>• There is a potential pinch point on the subframe; and</li> <li>• A potential for entrapment between the table and the gantry if the Operator/Technician stands between them to shift the patient forward</li> </ul>

<p><b>ACTION TO BE TAKEN BY CUSTOMER / USER</b></p>	<p>If you observe subframe motion (pictured below), when the system is powered on, in the nominal state, you can either complete the “Step-by-Step Instructions” or call your local service provider.</p> <p>Examples (but not limited to) when you may experience the subframe motion are as follows:</p>

<ol style="list-style-type: none"> <li>1. When loading / unloading a phantom for either:                     <ol style="list-style-type: none"> <li>a. QA checks</li> <li>b. Quick IQ Tests</li> </ol> </li> <li>2. When loading / unloading a patient</li> </ol> <p><u>Step-by-Step Instructions:</u>                      The below instructions and diagram will help you decide if a service provider should be called.</p> <ol style="list-style-type: none"> <li>1. System must be powered on, in its nominal state (ready for clinical use), with no patient on the table.</li> <li>2. Stand at the side of the patient support / couch towards the end farthest from the gantry.</li> <li>3. Grasp at the “Rear of Patient Support (Carbon Top)” (see arrow in diagram below).</li> <li>4. Without activating tape switch, attempt to move “Rear of Patient Support (Carbon Top)” away from the gantry (no motion is expected).                     <ol style="list-style-type: none"> <li>a. <u>If the subframe moves</u>, it is not locked in place. Discontinue clinical use and contact your service provider immediately.</li> <li>b. <u>If the subframe does not move</u>, visually verify that there is no misalignment as shown in the photo in Figure 2 in the Problem Description and the lower diagram below.                             <ul style="list-style-type: none"> <li>o If there is misalignment (identified by ‘Gap’ in the figure), discontinue clinical use and contact your service provider immediately.</li> <li>o If there is no misalignment, the system is clear for clinical use.</li> </ul> </li> </ol> </li> </ol> <p>Retain a copy of this Field Safety Notice with the equipment Instructions for Use (IFU).</p>
