**To the customers and users of the
emergency breathing devices
Oxylog 3000 and Oxylog 3000 plus**

Important safety information!!!

**Oxylog 3000, Oxylog 3000 plus
Failure of ventilation function with "Control knob faulty" error message**

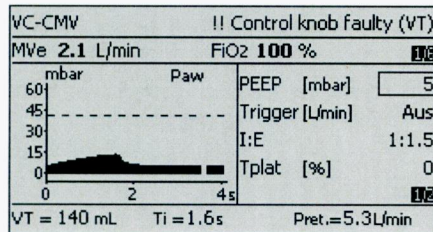
Our investigations indicate that the error condition is caused by an oxide layer in the potentiometer. These oxide layers may accumulate over a longer period of time if various factor collude i.e. if the knobs are moved rarely or never. A verified remedy is repeated twisting of the knobs that removes the oxide layer. This recommendation was described in the previous Safety Notice.

Whenever a “Control knob faulty” condition will occur with a device being equipped **with the new software the device will continue to ventilate with the last valid settings**, display for example the values for tidal volume in case of a defective potentiometer for VT and post the corresponding alarm (see Picture below)

However, this particular error condition was still reported from the field after the Safety Notice. The remedy of twisting the knob is still considered effective. Nonetheless, to reduce the impact of this special error condition Dräger has developed a new software that reduces the impact of the error condition.

Software version 1.06 will now be introduced for Oxylog 3000plus, version 1.23 for Oxylog 3000, respectively.

As reflected in the amended IfU you are advised to check patient's condition and the ventilation.
