Field Safety Notice (URGENT)

PASCAL Synthesis and PASCAL Synthesis TwinStar
(Systems with Endpoint Management (EpM) software feature Enabled)

Date: July 15, 2016

ADDENDUM

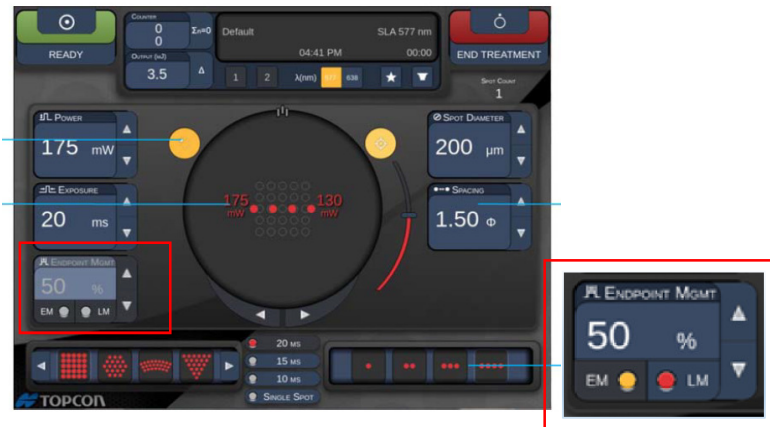
TMLS has discovered an anomaly with titration, only when EpM is turned on during the titration process.

This event may occur if the user turns on EpM, turns off the Landmark (LM) function (with any EpM supported pattern) and then enters titration mode. In either single or multiple spot titration patterns, the power output upon pressing the footswitch is the same as the EpM power. The EpM power is a percentage of the power selected in the EpM control. The user would expect the power output during titration to be equal to 100% of the selected power level and may increase the power level during the titration process. When the expected tissue response is not observed, the power level resulting from titration will produce an over-power treatment when the user subsequently treats with the titration turned off.

“Please perform titration ONLY with EpM software feature turned ON and Landmark feature turned ON. Prior to initiating titration, please confirm that the LM indication is in Red”

“Always verify the power settings on the screen prior to pressing the footswitch”
