Advisory Notice

Reference Number	BES080217/2	Date of Issue	08.02.17
Device	Stealth Flip Down Stems	Range of Devices	TWB480-17FDM TWB486-17FDM TWB480-1FDM TWB486-1FDM

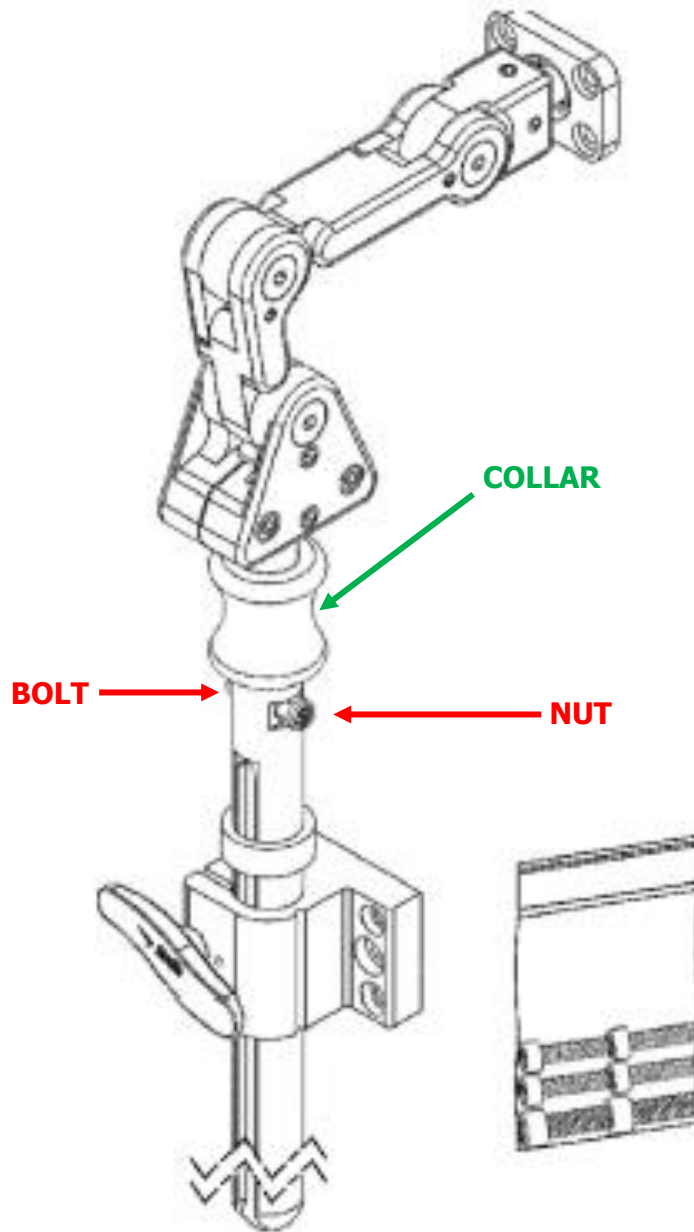
Appendix A

Problem
<p>The newest version of the flip down stems produced by Stealth Products Inc. (released May 2016) may have nuts and bolts within the stem which do not fully secure. Due to the two parts not fully securing the bolt can come loose. Indication of parts in Appendix A. The end of the bolt should be at least flush with the outside of the nut.</p> <p><u>Note:</u> Flip Down stems with the Button-release mechanism are not affected – only the flip down stems with the Collar-release mechanism are possibly affected (design of stem in diagram in Appendix A).</p>
Action by Whom
<p>BES to make contact with all customers who have purchased these stems since release. BES have checked all current stocks to ensure that no further at-risk stems are despatched.</p> <p>Stealth Products Inc. have confirmed that they have now changed the bolts that are being used in the manufacturing process to ensure that are secure.</p>

Action Required
<p>Customers to check that bolt end is at least flush with the outside of the nut on the stem. If the bolt is not flush with the nut or it is loose, BES will supply and fit new bolts and nuts for all that are identified.</p>
