Atellica® IM 1300 Analyzer  
Atellica® IM 1600 Analyzer

**Follow-up Communication for:**  
**Humidity Packs Incorrectly Identified as Expired (Lot 0010)**

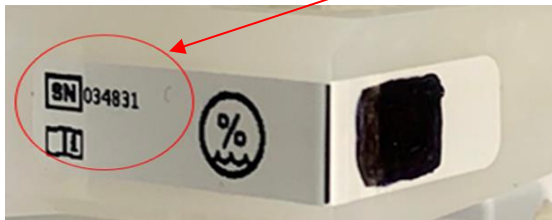
4. Select the **Reagent Loader** tab.
5. Select the **IM module** where the packs are to be loaded. Select **Manual Entry**.
6. Select pack type as **Ancillary**.
7. Enter the following barcode number.
  - a. 78713030PPPPPP
  - b. PPPPPP is a unique six-digit pack number. Use the unique identifier on the Humidity Pack being manually entered.
  - c. The unique identifier on the Humidity Pack label is depicted below. In this example the unique identifier is 034831. (side view)

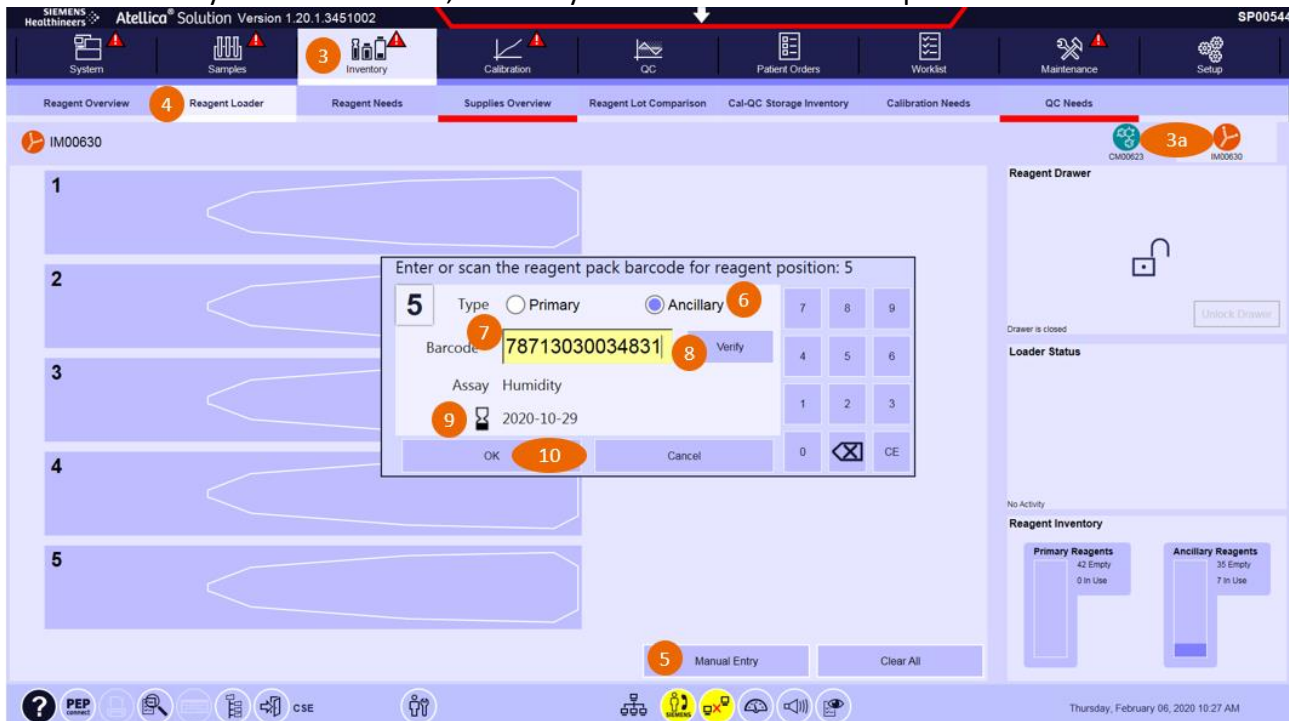
Note: Steps 3 through 9 correspond to the screen shot below.

8. Select Verify.
9. Confirm Assay equals Humidity and the date next to the hourglass symbol is 2020-10-29.
10. Select OK.
11. Load the Humidity Pack in position 5 of the reagent tray.
12. Repeat this procedure for all required Humidity Packs. Each analyzer will require, 7 to 10 packs based on analyzer environmental requirements. When the full set of required Humidity Packs are loaded, the analyzer will resume normal operation.
