Urgent Field Safety Notice

**Ambu AuraGain
December 11, 2015**

Ambu® AuraGain™ - Single Use Laryngeal Mask - Sterile

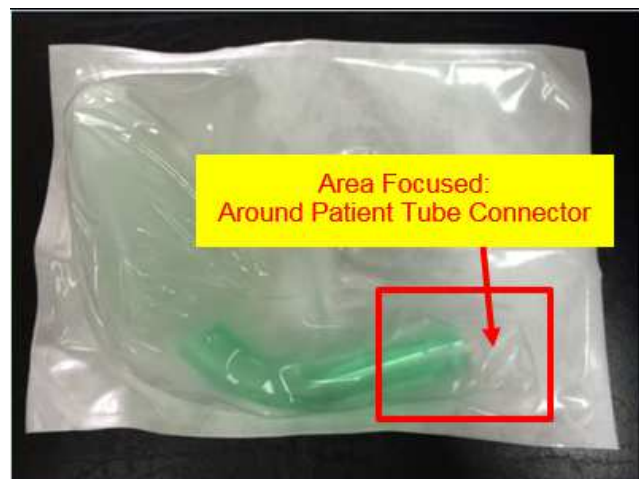
Step 1:

The cause of the potentially compromised sterile barrier is a small hole in the transparent film. Please see picture to the right, for a visual specification of the area to inspect.

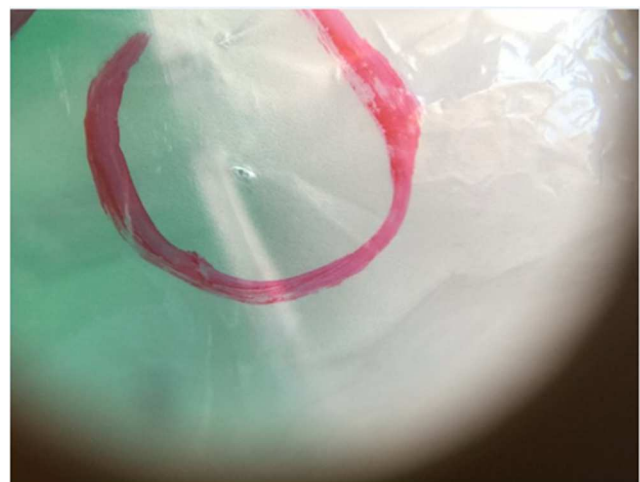
Step 2:

The inspection should be carried out in a setting with good light, to support best possible identification of breach. The breach is associated with a mark in the transparent film. If a device has a mark like illustrated on the picture to the right, it should be discarded. If in doubt whether a specific device has a hole, please discard.

Discarded devices should be collected and quarantined. Information on discarded devices should be kept and filled into appendix 3.
