Urgent Field Safety Notice

For a Subset of Medtronic Dual Chamber Pacemakers

Recall and Patient Management Recommendations

Medtronic reference: FA857

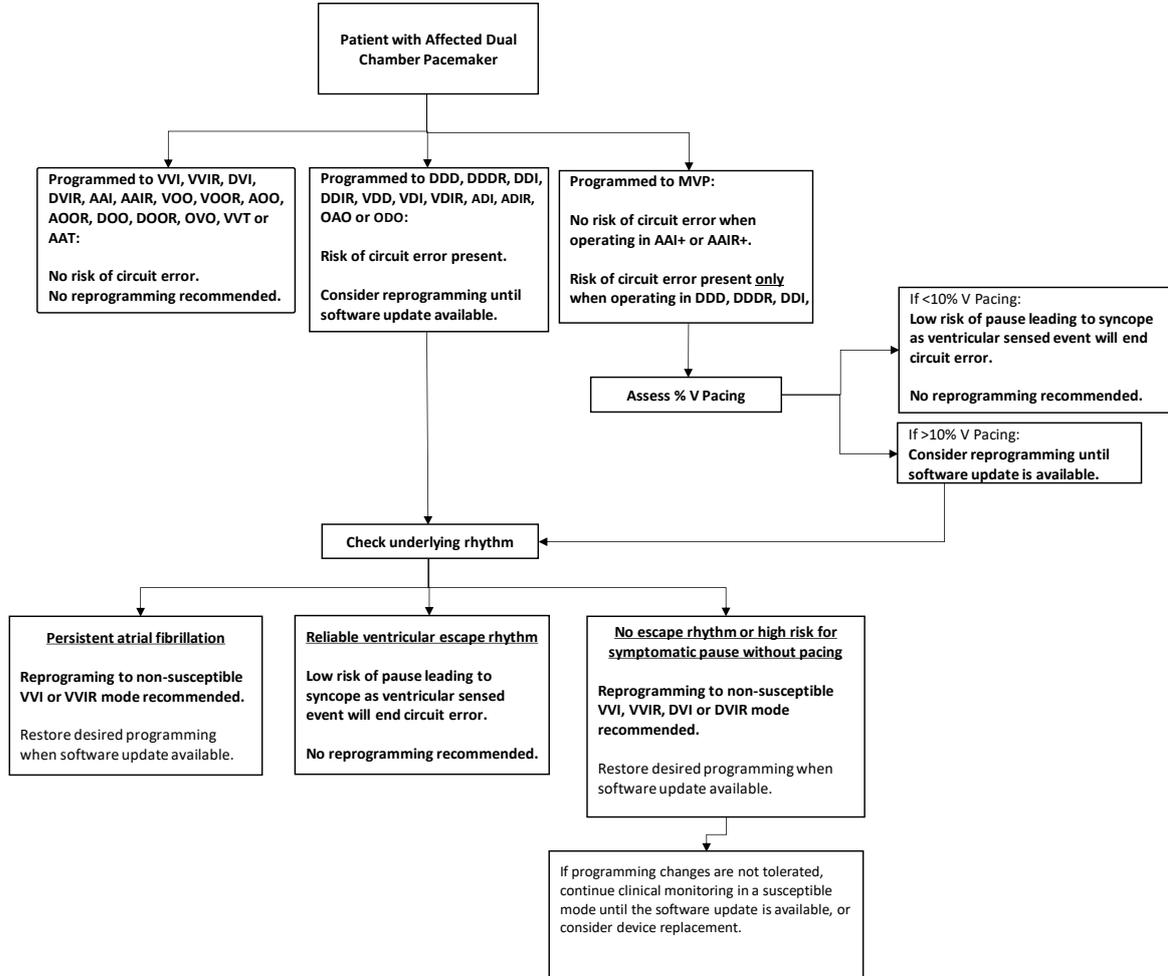
Appendix A: Programming decision flow chart

The root cause for this issue is related to a design change to an integrated circuit in a subset of devices that were distributed between 10 March 2017 and 7 January 2019.

We realize that each patient requires unique clinical considerations. In consultation with Medtronic's Independent Physician Quality Panel (IPQP), **Medtronic recommends programming to a non-susceptible pacing mode as the primary mitigation for patients implanted with an affected device until the software update has been installed.** Specific patient risk assessment and programming recommendations are outlined below and provided in Appendix A.

- **For patients whose device is programmed to a non-susceptible mode (see Table 1), no action is needed at this time. Continue routine clinical monitoring.**

- **For patients whose device is programmed to a susceptible mode and are continually in persistent atrial fibrillation, reprogramming the device to the non-susceptible VVI or VVIR mode is recommended to eliminate risk due to this issue until the software update has been installed. Continue routine clinical monitoring.**

- **For patients whose device is programmed to a susceptible mode and either: *have no underlying ventricular escape rhythm; or are at risk for a symptomatic pause until a ventricular escape beat occurs*, programming to a non-susceptible mode is recommended to eliminate risk due to this issue until the software update has been installed. Continue routine clinical monitoring.**

- **For patients who do not tolerate programming to a non-susceptible pacing mode and either: *have no underlying ventricular escape rhythm; or are at risk for a symptomatic pause until a ventricular escape beat occurs*, continue clinical monitoring in a susceptible mode until the software update is available, or consider device replacement.**
