Re: TravelChair Advisory Notice to Customers.

TravelChair Advisory Notice

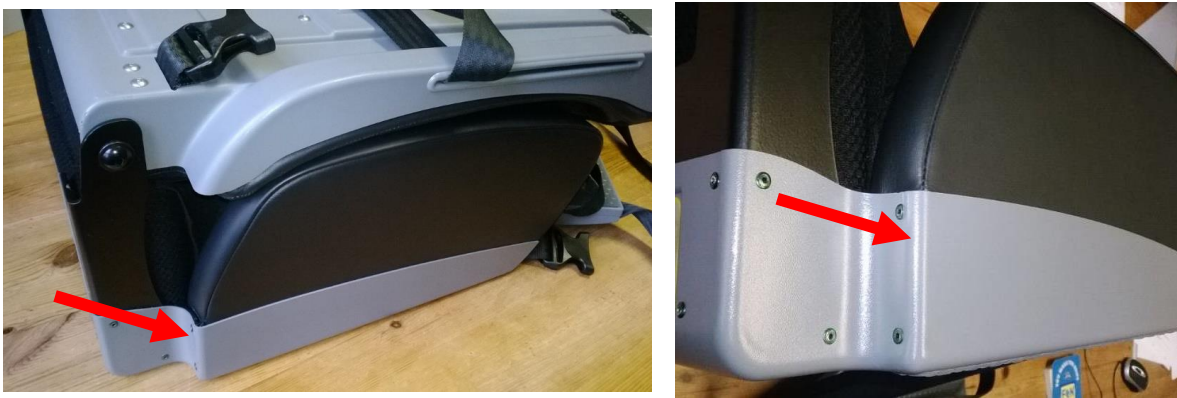
Figure 1.

It has come to our recent attention that some of our TravelChairs are showing signs of a stress fracture on the base (Figure 1, attached) which can lead to a fracturing of the plastic shell.

We understand that this situation is due to the back of the chair being dropped back on itself, causing a stress to develop in the shell and surrounding areas.

The fault: A crack is appearing on either side of the base of the TravelChair, shown below.

Please treat the TravelChair with care.
