## **URGENT MEDICAL DEVICE UPGRADE NOTIFICATION**

### **RE: STRYKER SONOPET CONSOLE**

July 11, 2014

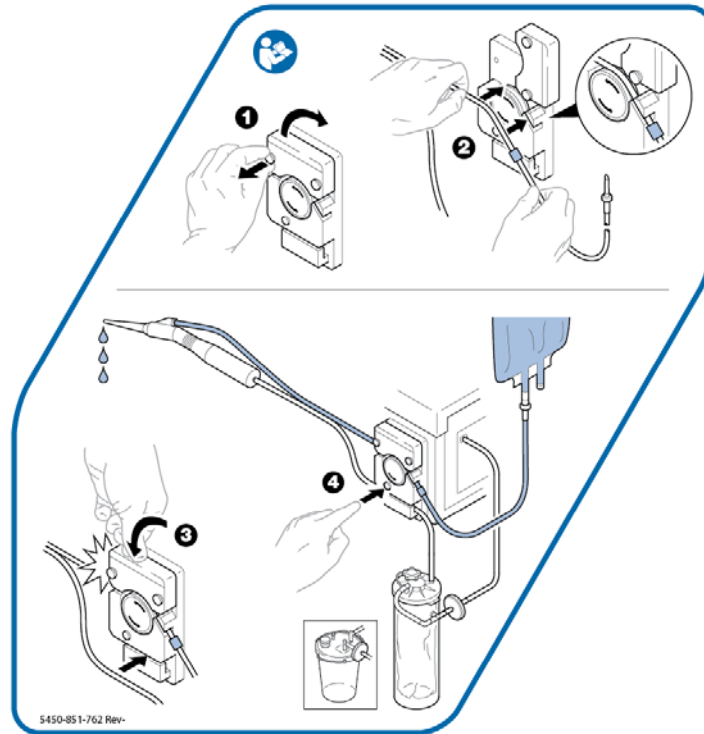
All existing Sonopet consoles will have an instructional irrigation setup label applied to the side of the console.

- Use of a rigid container or improper setup of the irrigation tubing may result in an inconsistent or lack of irrigation, which could result in excessive heat. Excessive heat from the Sonopet tip or handpiece due to insufficient irrigation may result in a risk of burning of critical soft tissue, burning of bone, and operator burn.

- A Stryker representative will contact you and come to your location to place the instructional irrigation setup label onto your Sonopet console(s). The label upgrade will be scheduled with you in advance. Each unit will take approximately 10 minutes to upgrade.
- When the label upgrade is completed at your facility, you will be asked to sign an Upgrade Completion Form confirming that a Stryker representative has applied the instructional irrigation setup label to all Sonopet consoles.
- Your signature and return of the Business Reply Form (BRF), which is included with this Notification, and receipt of upgrade documentation, will close out this recall for your facility.
