FSN 72800620

**URGENT - Field Safety Notice  
Medical Device Correction**

**Ingenuity CT, Ingenuity Core, Ingenuity Core<sup>128</sup>  
With Continuous Computed Tomography  
(CCT) Option and have been Upgraded from  
Software Version 3.x to Version 4.0.0 / 4.0.1**

**Protocol Conversion Resulting in Delayed Images when using CCT Option**

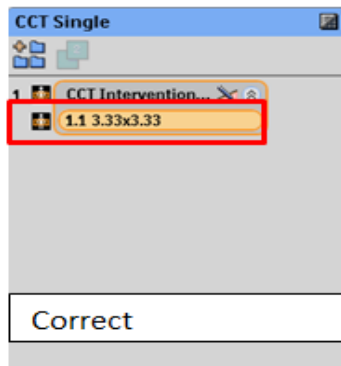
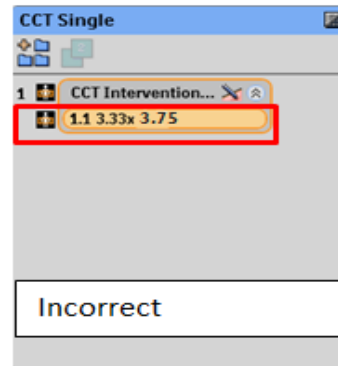
5. Double-click to open the CCT **Exam Card**.
6. Exam cards having the issue will have slice thickness and increment that do not match when opening the exam card. Please see example below:

- If the exam card has a mismatch, it is recommended to rebuild the CCT exam cards from the reference CCT exam cards.

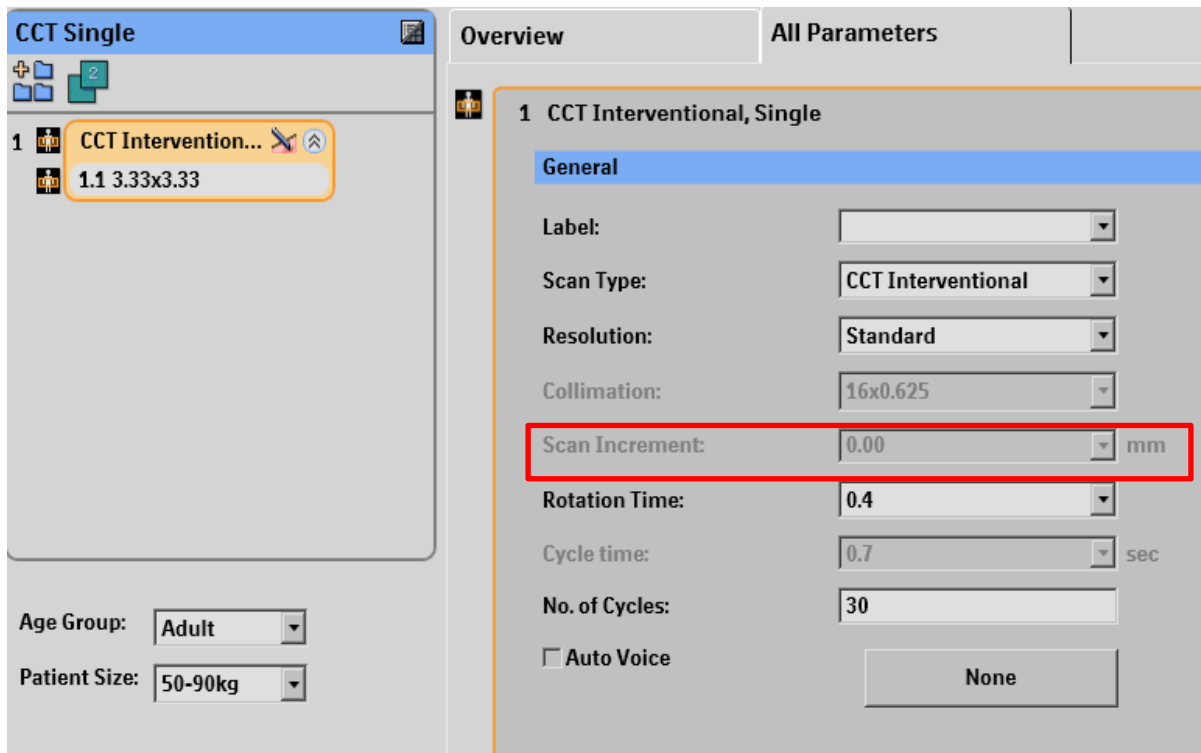
- Also note that when the acquisition step in the exam card is selected, the scan increment should be 0.00.
