**URGENT - Field Safety Notice**  
**Multidiagnost & UroDiagnost Eleva Systems (with or without Flat Detector).**  
**C-arm may float freely and possibly sag.**

This Field Safety Notice is intended to inform you that recently a problem has been detected related to our MultiDiagnost Eleva system, MultiDiagnost Eleva with Flat Detector and UroDiagnost Eleva systems. Philips has determined that two bolts in the system may break, causing the C-arm to float freely in the lateral direction and possibly sag.

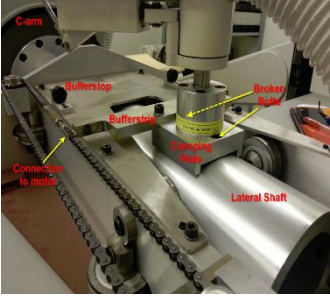
</div> <p>These pictures indicate where the bolts and lateral shaft are located in the scan carrier.</p>														
<p><b>HAZARD INVOLVED</b></p>	<p>If a sagging C-arm strikes a patient or operator, it could potentially result in a risk to health. However this risk to health is rarely to occur.</p> <p>To date, there have been no reports of injury associated with this event. There only has been one report of failure noted during a service call.</p>														
<p><b>HOW TO IDENTIFY AFFECTED PRODUCTS</b></p>	<p>All units of the systems identified above are affected. Your local Philips organization will help you confirm that all of your affected systems have been identified.</p>														
<p><b>ACTION TO BE TAKEN BY CUSTOMER / USER</b></p>	<ul style="list-style-type: none"> <li>• If the C-arm moves in any unexpected manner or fails to move when directed, please contact your local Philips representative immediately.</li> <li>• Ensure that all staff with access to affected systems are informed of the contents of this Field Safety Notice.</li> <li>• Place this letter with your user documentation.</li> </ul>														
<p><b>ACTIONS PLANNED BY PHILIPS</b></p>	<p>You will be contacted by our service organization to schedule an appointment to make the necessary repairs.</p>														
<p><b>FURTHER INFORMATION AND SUPPORT</b></p>	<p>If you need any further information or support concerning this issue, please contact your local Philips representative or the UK Philips Customer Care Service Centre on 0870 532 9741.</p>
