### Urgent Product Correction Notice

VITEK® 2 Identification / Antimicrobial Susceptibility Test Cards referenced in Appendix A **(one additional batch highlighted in yellow)**

**URGENT PRODUCT CORRECTION NOTICE -  
FSCA - 3445 – VITEK<sup>®</sup> 2 - Card Pouch Integrity**

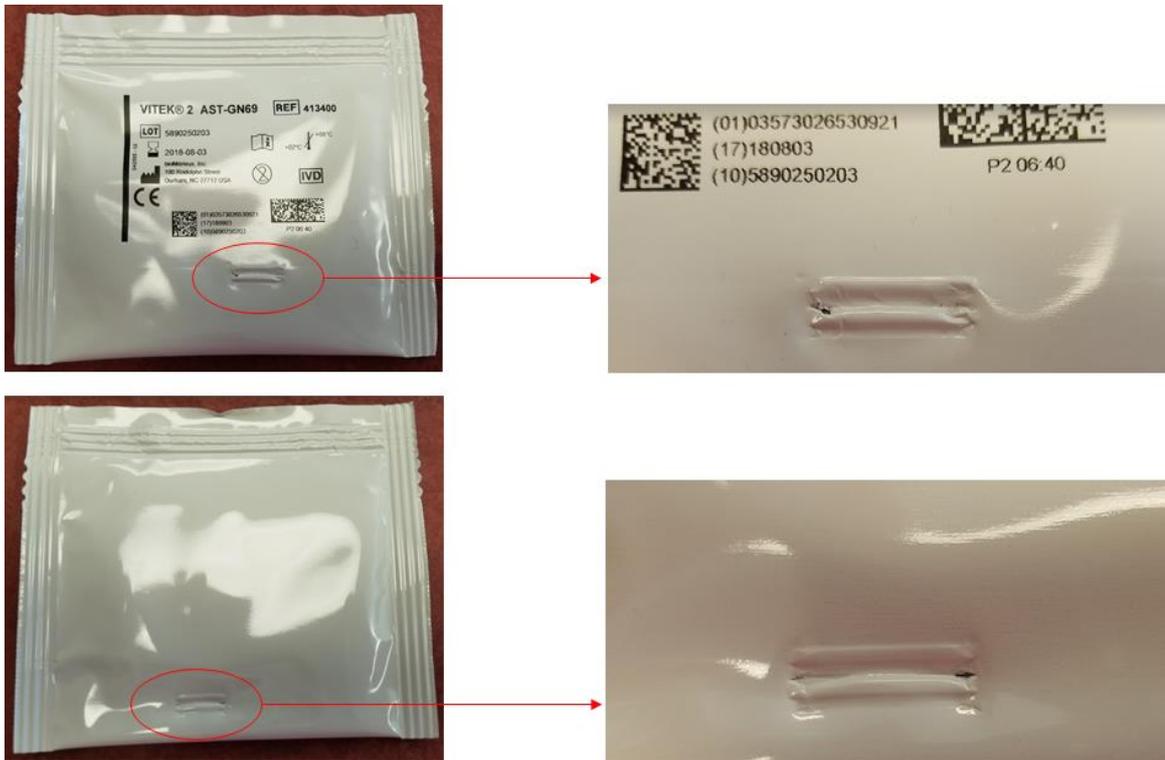
**Figure A - Example of Pouch Defect**

The white pouch is composed of five (5) layers of material, four (4) of which are clear. All five layers must be compromised for a pouch to potentially allow moisture to enter the pouch. Upon visual inspection of the pouch, you may notice a small puncture or tear in the packaging at the "stitch seal" **(see Figure A immediately below)**. Per product labeling, do not use the card if the pouch (the white protective package cover) is damaged. Based on internal testing, approximately 20% of card pouches exhibited a visual defect; the majority of card pouches with this visual defect maintained pouch integrity, i.e. at least one of the five material layers remained intact. However, 1 in 200 (0.5%) card pouches that passed careful visual inspection failed further integrity tests, indicating the potential for entry of moisture.

1. Check the lot numbers in your inventory against the lot numbers listed in Appendix A.
2. For impacted lots, visually inspect the test card pouches on both sides for the defect.

- a. If the defect is observed, destroy the associated test card(s) and contact our Technical Service Department on 0044 (0) 1256 480711 or email [uktechnical@biomerieux.com](mailto:uktechnical@biomerieux.com) for credit. Until such time as card lots with the new stitch seal become prevalent, there is the potential that replacement cards will include a product lot listed in Attachment A. In this event, please continue to follow these instructions.

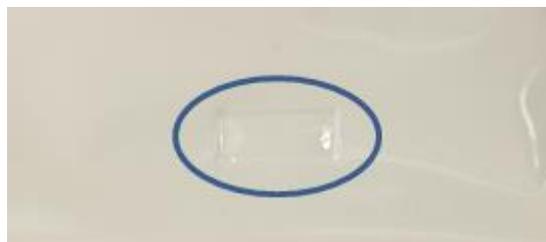
**Figure B - New Stitch Seal**

The root cause of this issue has been identified and corrective measures have been taken to ensure issues of this type do not affect future Manufacturing lots. Card lots manufactured after March 16, 2017 include a new stitch seal (see Figure B below) and are not affected by the described issue.
