Field Safety Corrective Action (FSCA) for Tomcat™ Instrument Pipettor Arm Error

All Tomcat™ instruments Catalogue Number: ASY-07379 / RASY-07379

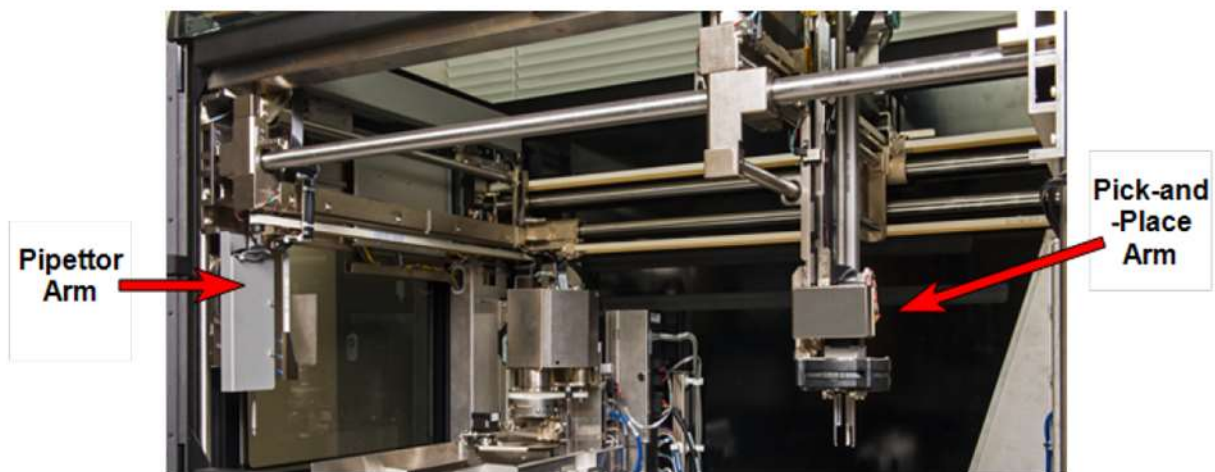
Figure 1. Location of the Tomcat instrument pipettor arm.

Hologic's investigation has identified the root cause of this issue to be a software anomaly which, in rare cases, can impact the Tomcat instrument's pipettor arm (Figure 1) causing the sample pipette tip position to offset slightly lower than normal. If this occurs, error code 18 may be displayed and/or a clicking or scraping sound may be heard due to sample tip contact with the mucous shelf (Figure 2).

This issue can occur during pipettor arm initialization when the system is jostled by an external source or by the pipettor's own movement.

- A software update to correct the software anomaly is available for onsite installation by a Hologic field representative. This software update will prevent this issue from occurring by correcting the initialization movements during the pipettor arm homing routine. Hologic will be contacting customers to schedule the software update installation.
- If error code 18 is observed prior to receiving the software update, or if a clicking or scraping sound is heard as the Tomcat instrument's pipettor arm moves across the mucous shelf, please discontinue using the Tomcat instrument and contact Hologic

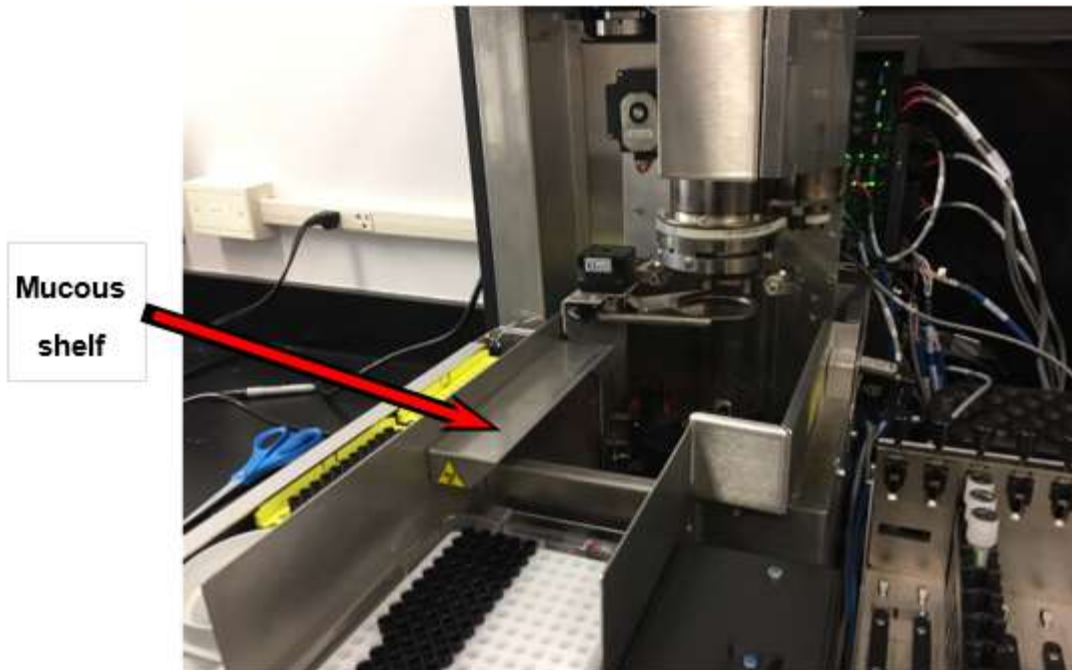
Figure 2. Location of the mucous shelf.

There have been **no reports of incorrect sample results** being associated with this anomaly. While sample pipette tip position offset appears to occur at a low frequency, if it occurs, sample tip contact with the mucous shelf could result in incorrect sample results due to sample tip contamination, or due to volume loss from the tip. NOTE: Tomcat does not produce any results, however, these potential incorrect results could occur when tested subsequent to sample processing on the Tomcat.
