URGENT IMPORTANT FIELD SAFETY NOTIFICATION

Subject: Potential incorrect positioning after verification scan

Product: iGUIDE® Software 2.2

Scope: iGUIDE® 2.2.0, iGUIDE® 2.2.1

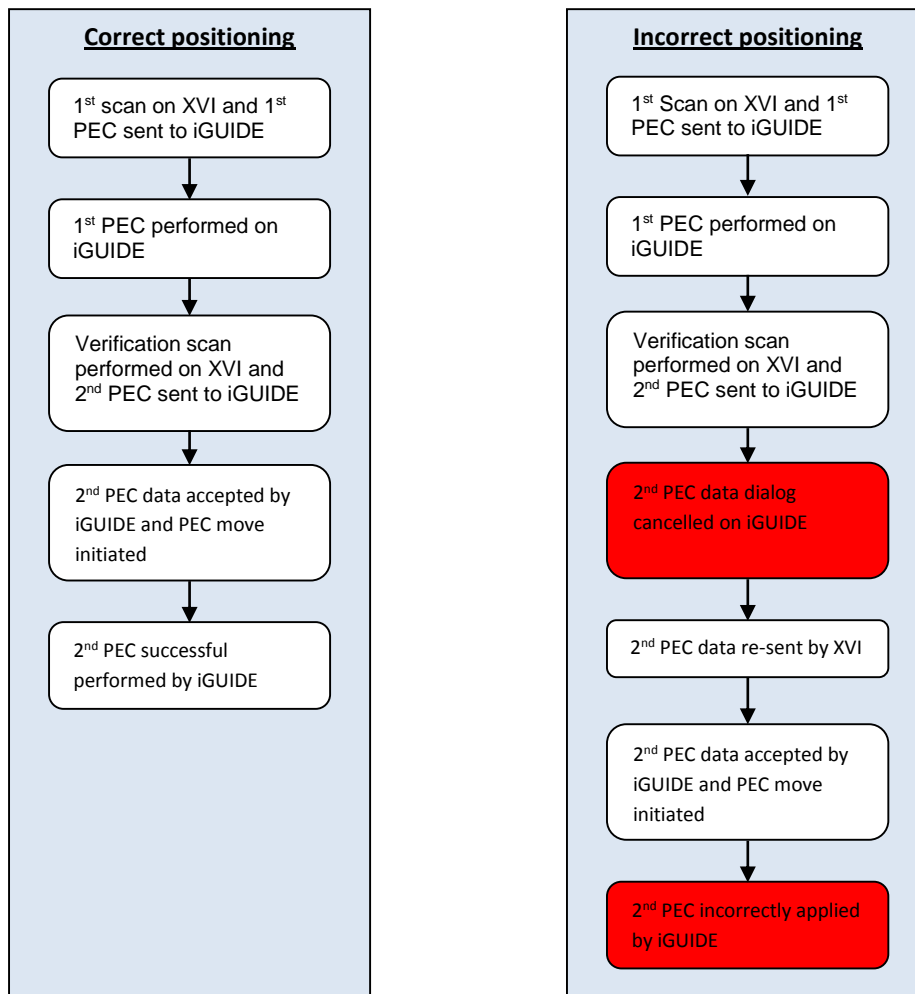
The following image compares the iGUIDE workflow scenarios with correct and incorrect positioning.

- On the left a normal workflow including verification scan with correct positioning is shown.
- On the right the unusual workflow with wrong positioning is shown. The error occurs when the 2nd PEC data dialog is cancelled and the re-sent PEC is executed.

Incorrect positioning (values of 1st PEC are overwritten) - Risk of mistreatment.

Do not cancel the 2nd iGUIDE PEC data dialog (and confirm the cancellation) for a verification scan. If you have cancelled the 2nd PEC data dialog, you have to restart the positioning and return to the beginning of

A software update will correct the behavior of the affected iGUIDE versions 2.2.0 and 2.2.1. As soon as available it will be installed at no charge.
