URGENT FIELD SAFETY NOTICE

FSCA identifier: HV-SAL-2018-001
Affected Product: Perceval Sutureless Heart Valve
Type of action: Advice given by the Manufacturer regarding the use of the device
Date: June 18, 2018
Attention: Implanting Surgeons
Reason: Possibility of stent folding due to Perceval valve oversizing

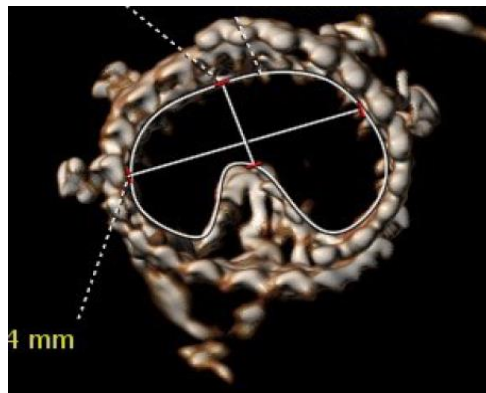
Stent folding is defined as an inward deformation of the stent at the annulus level (see Figure 1).

Figure 1. Stent folding

The main root cause identified for stent folding is valve oversizing, associated with other factors such as:

- extremely eccentric aortic annulus;
- highly calcified portion of the annulus, or uneven decalcification (concentrated bulky calcium protrusion);
- aortic root anatomy deviating from the tri-symmetrical physiological geometry (bicuspid valve, or absence of one of the Valsalva sinuses);
- severe hypertrophic septum.

- 1) Decalcification, to avoid uneven surfaces;
- 2) Correct sizing, using available information in the IFU; and
- 3) Ballooning, with the recommendation to pour warm sterile saline (at 37°C) while ballooning.

- 1) Visual inspection, checking that the Perceval stent is correctly deployed; and
- 2) Performing an intraoperative echographic evaluation after Perceval implant to confirm correct positioning and verify valve functionality under beating heart conditions.
