URGENT FIELD SAFETY NOTICE

Loss of pacing and sensing following hardware failure, leading to absence of automatic detection of an arrhythmia requiring defibrillation shock therapy

FSCA identifier: CRM-SAL-2018-001

Affected devices: Limited subset of Platinum Implantable Cardiac Defibrillator (ICD) and Resynchronization Therapy Defibrillator (CRT-D) models : VR 1210, VR 1240, DR 1510, DR 1540, CRT-D 1711, SonR CRT-D 1811, CRT-D 1741, SonR CRT-D 1841, 4LV CRT-D 1744, 4LV SonR CRT-D 1844

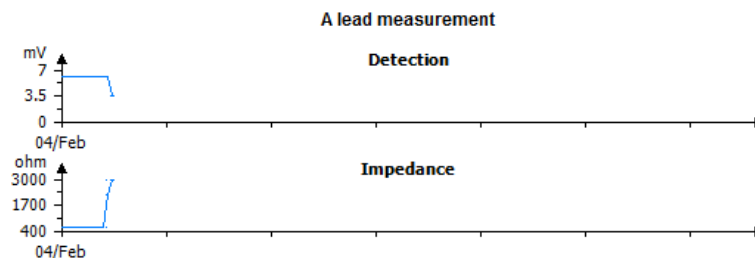
- a. The warning “Technical issue” indicates that overconsumption was detected. A steep decrease of the battery voltage may be visible on the battery curve.
- b. Warnings on high lead impedances in all cavities.
- c. Loss of sensing capability will result in flat EGMs and 100% pacing in the statistics.

Atrial lead impedance curve showing a sudden increase of the impedance

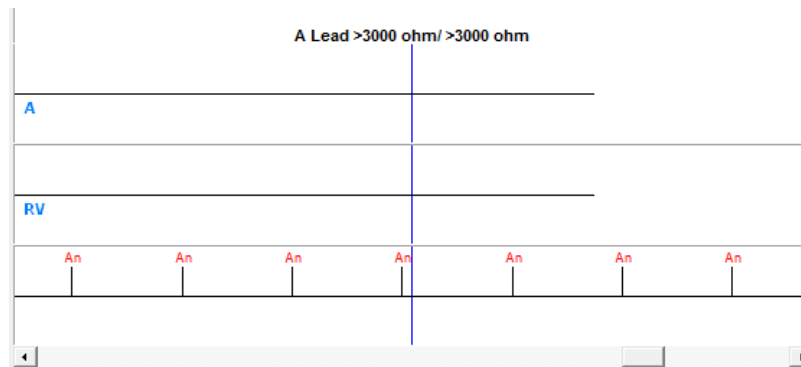
Flat EGMs

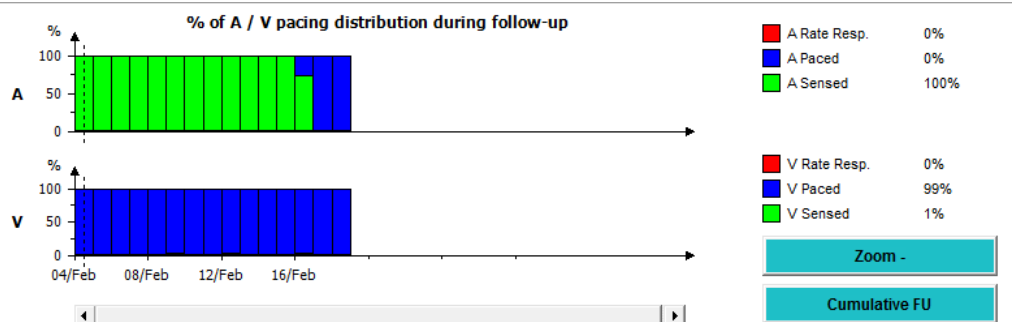
Statistics showing 100% pacing

When the failure described in this Field Safety Notice occurs, the device will no longer pace or sense. Due to the absence of sensing, the algorithm will send a pacing command for 100% of the cardiac cycles. The pacing spikes are not delivered due to the hardware failure, but 100% pacing statistics will be shown.
