## Urgent Field Safety Notice

**Subject: Field Safety Notice** – Continued use of older Model 2868 software on Model 3120 ZOOM™ programmers to support transvenous CRT-Ds and ICDs until supply chain constraints on newer programmers<sup>1</sup> are resolved. See Appendix A for affected GTINs (Boston Scientific Field Action Reference: 92822246-FA)

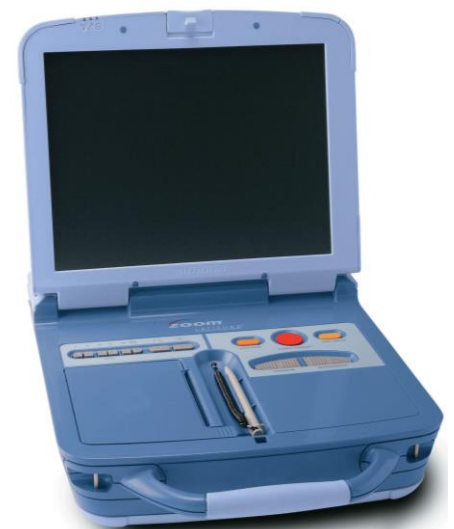
**Figure 1.** Model 3120 ZOOM Programmer

- Global supply chain challenges have constrained availability of the newer programmers.
- Until the supply chain constraints are resolved locally, you may continue using older 3120 ZOOM programmers.
- The 2868 software on the 3120 ZOOM programmer has been uninstalled or is outdated. As such, users may observe unexpected behaviors when attempting communications with transvenous defibrillators<sup>2</sup> including the potential inability to interrogate or the display of incorrect/missing parameters<sup>3</sup>
- A software update has been developed to resolve some of the disruptive behaviors associated with continued use of 2868 software on the 3120 ZOOM programmer. Boston Scientific will release software after local approval.

- The risk of insufficient programmer supply outweighs the risks associated with these unexpected behaviors, therefore, Boston Scientific recommends continued use of 3120 ZOOM programmers for transvenous defibrillators until sufficient supply of the newer programmers can be achieved locally.

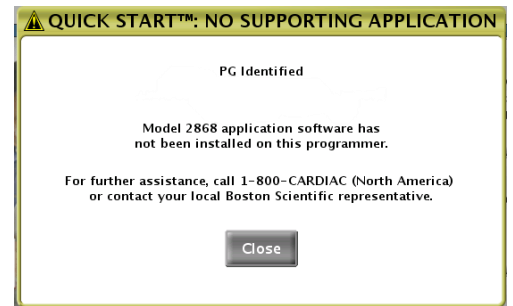
As part of this software upgrade, product labeling was updated to direct users to avoid using outdated 2868 software and Boston Scientific began uninstalling this software from 3120 ZOOM programmers. Soon after, Boston Scientific became aware of the likelihood of pandemic-induced global supply chain constraints on 3300 LATITUDE programmer supply and discontinued the uninstallation process in most regions because there could be insufficient programmers to support implanted TV defibrillators. When 2868 software is uninstalled, the 3120 ZOOM programmer can no longer interrogate TV defibrillators. If a user attempts to interrogate a device without applicable software, a message is displayed (Figure 2) to notify the user that software has been uninstalled on the programmer. To determine if a programmer has 2868 software, select “About” on the programmer screen and review the list of software applications installed. Please note that, 2868 software is the only outdated application on the 3120 ZOOM programmer.

**Figure 2.** Message that displays when a Boston Scientific TV defibrillator is interrogated by a 3120 ZOOM programmer if 2868 software is uninstalled.

The behavior most likely to be attributed to potential harm when using a 3120 ZOOM programmer is the inability to interrogate a TV defibrillator (e.g. Figure 2 or 3). There have been 9 reports of this behavior which have resulted in a delayed/prolonged procedure until the defibrillator can be interrogated with a 3300 LATITUDE programmer. Furthermore, there has been a single report of delays in reprogramming for phrenic nerve stimulation and a single report of an inability to interrogate for delivery of commanded therapy. None of the reports associated with 3120 ZOOM programmer have resulted in permanent injury.

- 1) If unable to interrogate a TV defibrillator with a 3120 ZOOM programmer, use a 3300 LATITUDE programmer instead. If this behavior occurs, STAT PACE, STAT SHOCK, and DIVERT THERAPY programmer operations<sup>4</sup> are not available through a 3120 ZOOM programmer, so external pacing/defibrillation or magnet application (to divert shock) may be required if a 3300 LATITUDE programmer is not immediately available.

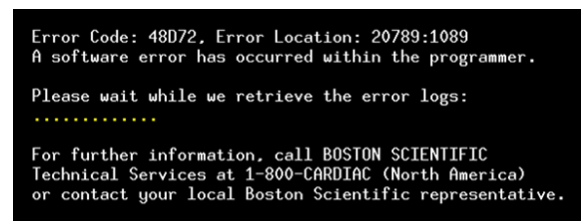
If a TV defibrillator has a stored SAM episode, the 3120 ZOOM programmer will present the Error Log and Halt message in Figure 3, and the user will need to use a 3300 LATITUDE programmer to interrogate the defibrillator. This error message (Figure 3) is an indication of an incompatibility of any 3120 ZOOM programmer with that specific TV defibrillator. However, the TV defibrillator will operate as intended with the permanently programmed settings. After power cycling the programmer, it may be used to interrogate TV defibrillators without stored SAM episodes. If the user attempts to interrogate the same TV defibrillator with the 3120 ZOOM programmer, the Error Log and Halt message will display again.

**Figure 3.** The specific Error Log and Halt Message on 3120 ZOOM Programmer when interrogation of TV defibrillator with a SAM episode is attempted.

A 3120 ZOOM programmer update to 2868 software has been developed to resolve the Error Log and Halt behavior associated with TV defibrillators having a stored SAM episode. This software update does not represent a material reduction in patient safety risk, however, it does prevent clinical workflow interruptions and will be released subsequent to approval.
