URGENT: VOLUNTARY FIELD SAFETY NOTICE		
Description	Handling guidance for specific catalog numbers of Alcon Phaco Tips when used with included plastic wrench	
Relevant Product	Alcon Phaco Tips (see Attachment 1)	
Alcon Record ID	2023.011

5<sup>th</sup> July 2023

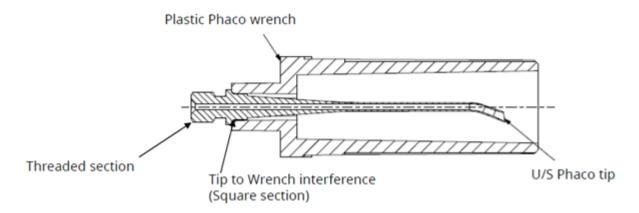
Alcon has become aware of the potential for the Phaco Tip wrench to generate plastic shaving particles if the Phaco Tip is over-tightened to the handpiece to the point where the wrench slips over the tip-to-wrench interface.

Please review the following information regarding specific catalog numbers of Alcon Phaco Tips and packs or kits containing those Phaco Tips. The purpose of this letter is to provide you with additional guidance on handling of the plastic wrench when tightening the Phaco Tip to mitigate the risk of generating plastic particles.

- A. In order to mitigate the potential for the wrench to be damaged by overtightening the Phaco Tip and associated generation of plastic particles, Alcon is advising customers of the following precautions:
  - To fasten the tip into the handpiece, grasp the plastic wrench by the cylindrical part of the wrench. Overtightening by leveraging the wings can increase the likelihood that the wrench may slip over the tip-to-wrench interface, causing damage to the wrench, and has the potential to generate plastic particles which may remain on the exterior of the Phaco Tip and/or distal end of the phaco handpiece.
