Field Safety Notice

2023-JULY-13 | MX-8905 | Rev 01

MCC-23-001-IU: Broken locking rings found in HL 40 roller pump heads

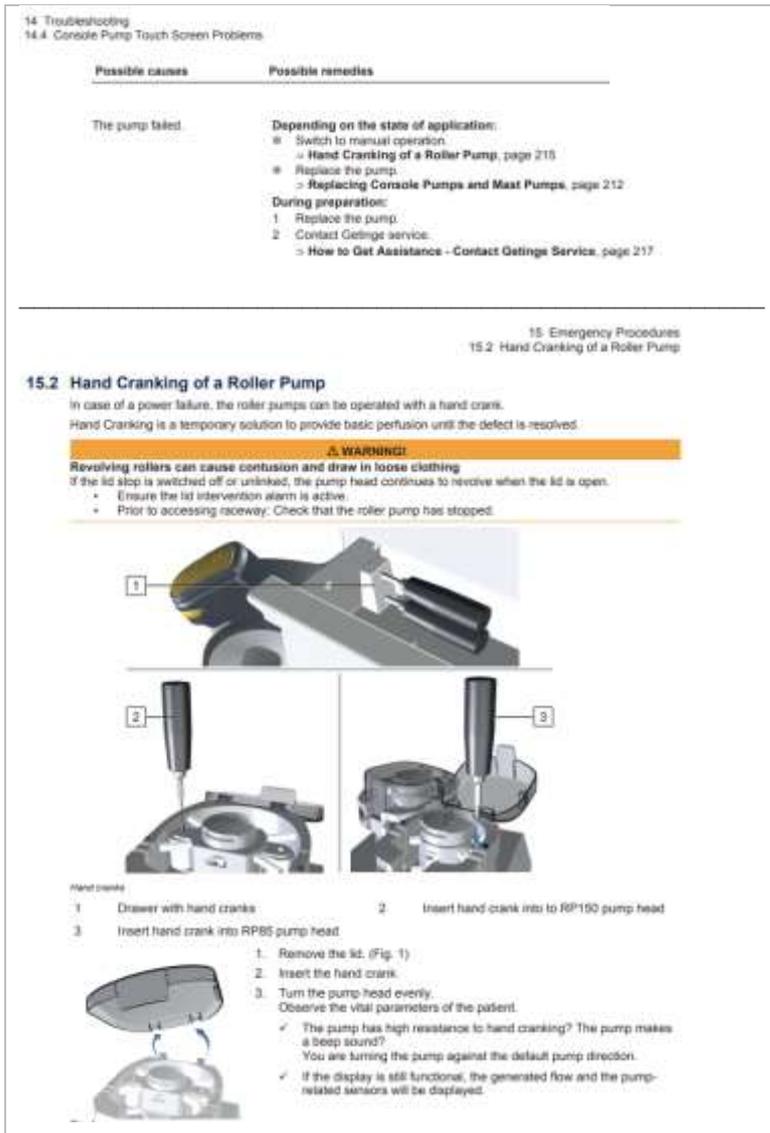
Figure 1: Hand crank deployment as described in HL 40 IFU [70105.8274·2.1·NONUS·en·06·2021-02].

- If an alarm message is elicited by the HL 40 user interface, please consider the contextual, recommended actions as indicated by the HL 40 Help screen displayed on the system monitor and the IFU.
- in the improbable event of a failure, or unrecoverable fault, of the roller pump the user should be prepared to deploy the hand crank as described in the HL40 IFU.
