Urgent FIELD SAFETY NOTICE

Ceiling pendant SPR 10

08/05/2015

Device Modification

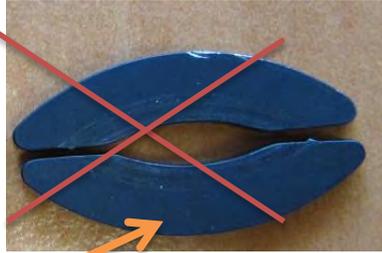
„former“ segments

Don't have the notch on the outer edge segment.

Continuing to use the old axial segments when they have a thickness of less than 1.7mm may lead to following situations:

1. The fall of the accessories to the operation or examination field.
2. Neglect of the periodic technical safety inspection may lead to grinding through of the axial segments and subsequent disengagement of the whole device during the operation or physical examination of the patient. Such an omission may have serious consequences for the medical staff and the patients.

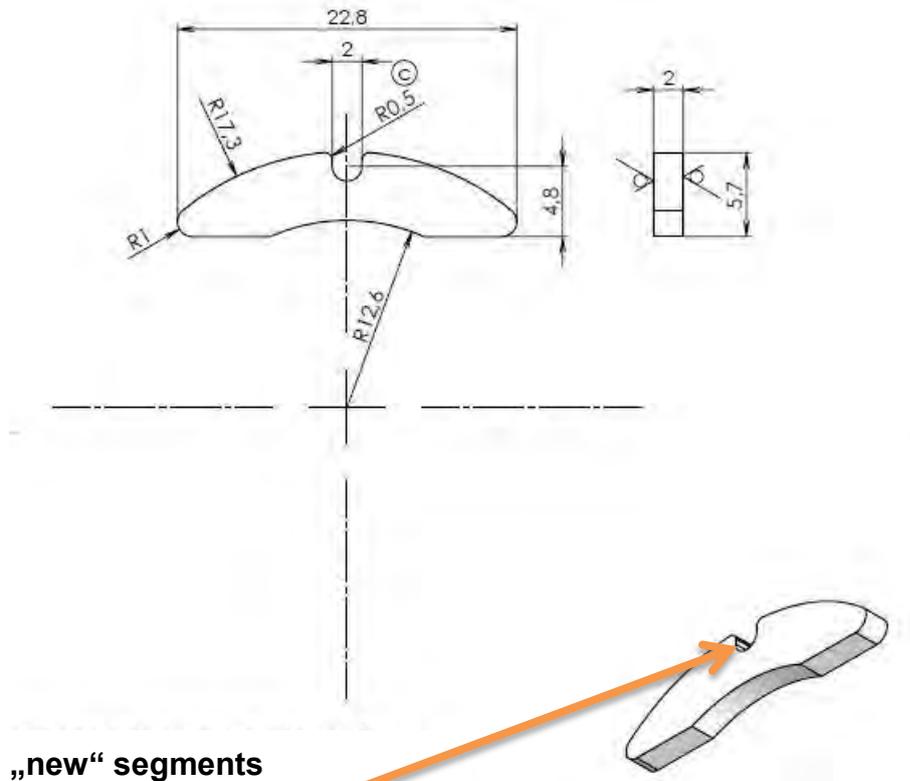
„new“ segments

Have the notch on the outer edge segment.
