### Safety Advisory Notice

SOMATOM Emotion 6 Slice Configuration

SOMATOM Emotion 16 Slice Configuration

**Re: SOMATOM Emotion 6 / 16 Slice Configuration with fatigued bolts holding the balance weights of the data measurement system (DMS)**

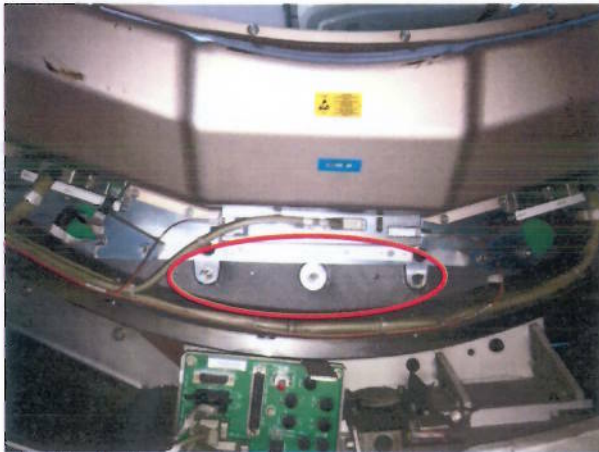
We recently detected that the bolts (Fig. 1) used to fix the balance weight of the DMS may show signs of metal fatigue. Accordingly the function of these bolts may potentially degrade over time and impact stability.

Fig. 1: Bolts used to fix the DMS balance weight

The rupture of a single bolt is not posing a hazard by itself but it cannot be fully ruled out that all the bolts break over time causing the DMS balance weight to drop into the gantry. As a consequence ongoing scans will be aborted immediately. Under unfavorable circumstances mechanical damage of the gantry cover and of the Plexiglas protection ring inside the gantry opening may occur. This situation potentially exposes the patient or operator to the risk of getting into contact with rotating parts.

We have carefully analyzed this issue and developed a solution improving the mechanical stability of the assembly. As instructed by the Update Information UI CT008/15/P our service engineers will start in Mai - 2015 to replace all the bolts holding the DMS balance weight by a new model. The aging properties of the new bolts are far superior and material fatigue resistance is drastically increased.
