Philips Healthcare

FSN86201683B FSN86201684B
January 2016

**URGENT – Field Safety Notice
Philips IntelliVue Information Center (PIIC) iX**

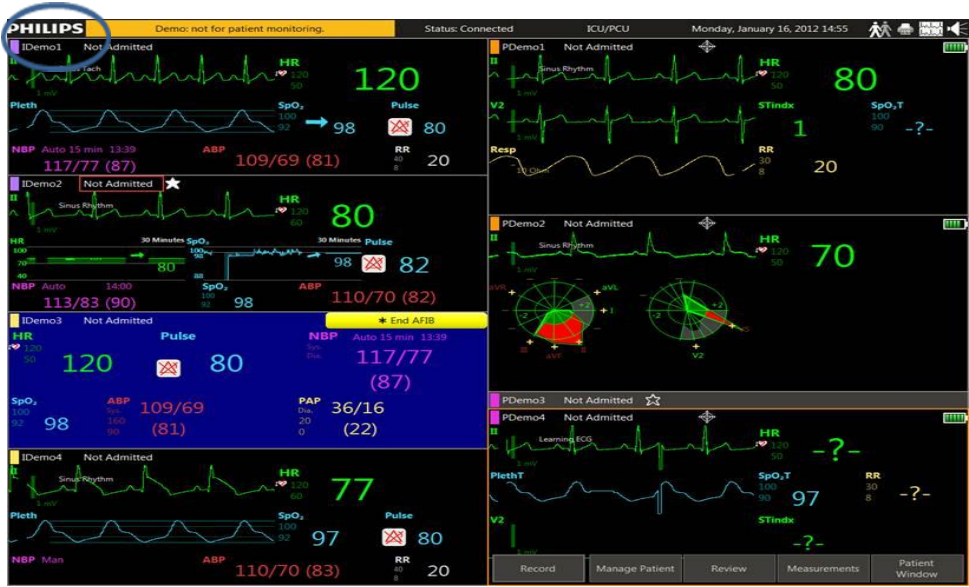
<p>HOW TO IDENTIFY AFFECTED PRODUCTS</p>	<p>PIIC iX Revision A.0X or B.0X – Identify the affected product by clicking on the Philips watermark on the PIIC iX surveillance display. This will bring up the Product Support Page. Software Version has the release that the product is running.</p>
