UPDATED URGENT FIELD SAFETY NOTICE – FSN-33718-2

PRODUCT	REF	Software Versions
UniCel DxH 800 Coulter Cellular Analysis System	629029, B24465, B24802, B68304, B66445, B63322	All
UniCel DxH 600 Coulter Cellular Analysis System	B23858	All
UniCel DxH 900 Coulter Cellular Analysis System	C11478	All

This notification replaces our previous urgent Field Safety Notice Letter dated August 10, 2018 concerning sporadic erroneously elevated platelet results. Beckman Coulter is initiating a field action for the products listed above. This letter contains important information that needs your immediate attention. Patient results may be affected. No death or serious injury has ever been reported in association with this issue.

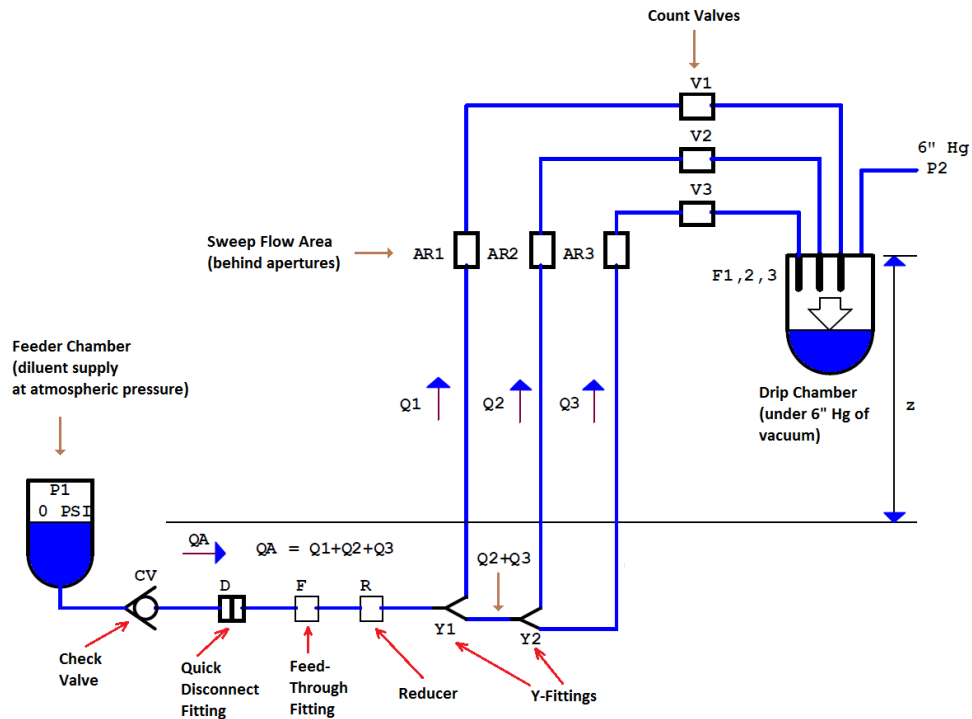
<p>ACTION:</p>	<ul style="list-style-type: none"> • Ongoing investigation indicates that the probable root cause is the sweep flow disruption that may occur following the “Clear RBC Apertures” procedure. This potential root cause is currently under further investigation. Customers should discontinue using this procedure. • If you suspect that your instrument has a clogged aperture that will not clear, discontinue use of the analyzer and contact your local Beckman Coulter representative for further assistance. • Use the following quality control measures to aid in identification of discrepant platelet results: <ul style="list-style-type: none"> ○ Follow your laboratory’s standard operating procedure to confirm unexpected results. ○ Repeat testing of samples in a workflow configuration may facilitate the identification of discrepancies. ○ Additional instrument and/or LIS features including reference ranges, XM (exponentially-weighted moving average) and delta checks may be informative. • Consult with your Medical Director to determine if a retrospective review of results is warranted. • Report any unflagged erroneously elevated platelet counts experienced in your laboratory to your local Beckman Coulter representative.

Figure 1 Sweep flow schematic. $Q1/Q2/Q3$ are 96 inches of low diameter tubing. Air is injected into the system when one of the lines has air pushed past to the Y1/Y2 fittings from the clearing process originating at F1,2,3.

<p>RESOLUTION:</p>	<ul style="list-style-type: none"> • To detect and flag erroneously elevated platelets due to temporary disturbance of the sweep flow, Beckman Coulter implemented an algorithm improvement. This algorithm improvement was implemented by way of one of the following: <ul style="list-style-type: none"> • Software upgrades, DxH 800 version 3.2.1 and above and DxH 600 version 1.3.1 and above. • Customer-installable software patch made available in October 2018 • Software version 1.0.0 and above for DxH 900 • If your DxH 800 / DxH 600 system has not yet been upgraded with the improved algorithm, please contact your local Beckman Coulter representative. All fielded DxH 900 analyzers have the improved algorithm incorporated into their original software. • Beckman Coulter continues to investigate the unflagged elevated platelets issue and assess the “Clear RBC Apertures procedure” as well as other potential root and/or contributing causes.

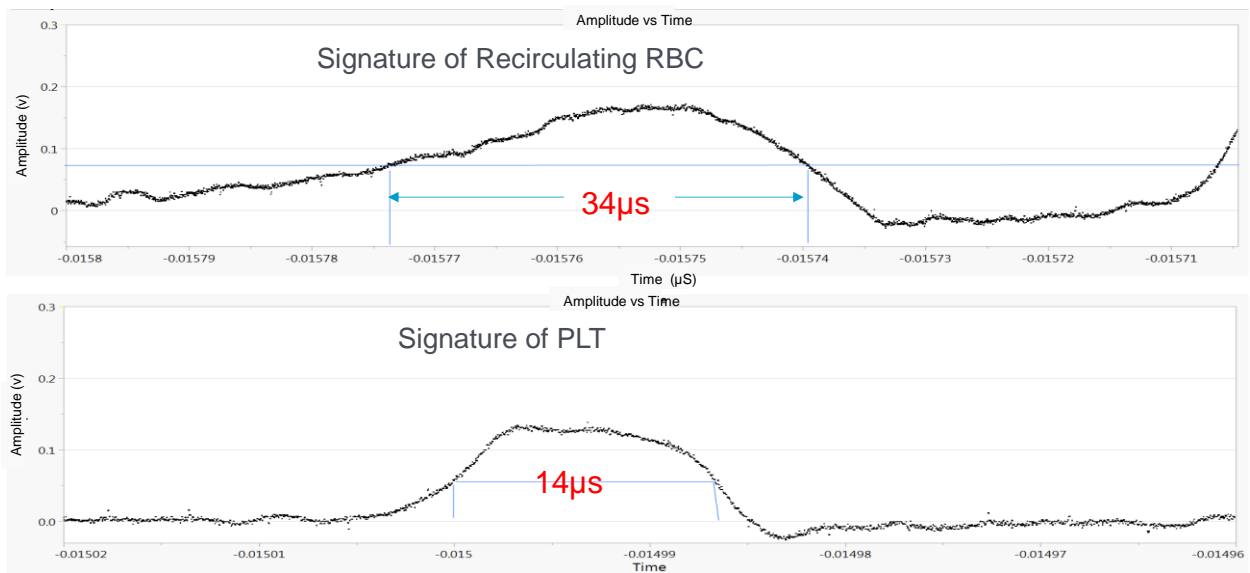
Figure 2 (Top) Oscilloscope capture of a pulse believed to be a recirculating RBC; (Bottom) Oscilloscope capture of a normal platelet. Note the difference in FWHM.
