5<sup>th</sup> June 2023

**URGENT FIELD SAFETY NOTICE  
MEDICAL DEVICE CORRECTION  
FSCA 2249723-05/05/2023-008-C**

**Datascope Cardiosave Hybrid and Rescue Intra-Aortic Balloon Pumps (IABP)**

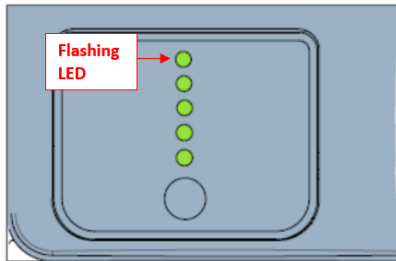
Figure 1: Battery is 80% - 100% Charging

Each Battery has five (5) LEDs indicating the battery's approximate state of charge. **A battery with 80% charge is represented by four (4) solid illuminated LEDs and when charging, the topmost LED on the battery will be flashing. Removing the battery when the top LED is flashing during the charging operation may result in damage to the Cardiosave's battery charging circuitry.**

Do NOT remove battery

To prevent electrical surges that may impair the Cardiosave's ability to charge batteries, **do not remove the battery** from a Cardiosave **when the battery level is at 80% or higher and actively charging** (i.e. successfully connected to AC power). Keep the battery in the charging bay until fully charged.

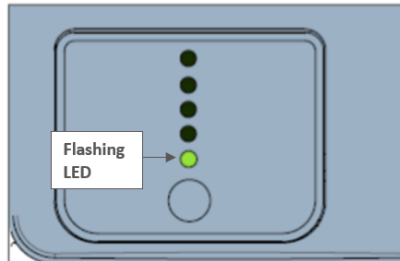
Figure 2: Battery 0%-20% Charging

Safe to remove battery

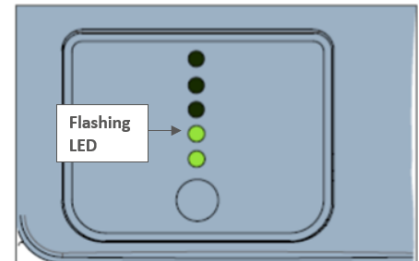
Figure 3: Battery 20%-40% Charging

Safe to remove battery

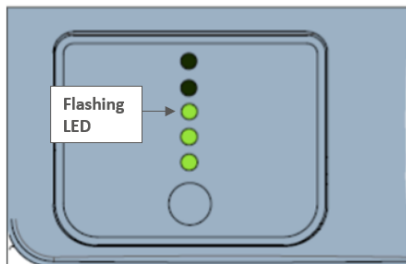
Figure 4: Battery 40%-60% Charging

Safe to remove battery

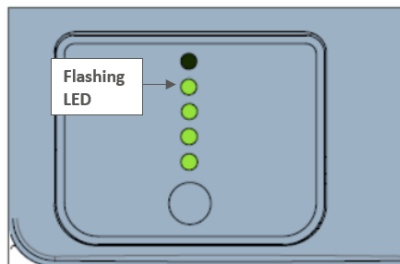
Figure 5: Battery 60%-80% Charged

Safe to remove battery

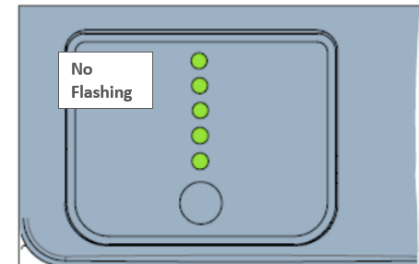
Figure 6: Fully Charged Battery

Safe to remove battery
