IMMULITE® 2000
IMMULITE® 2000 XPi

Water and Liquid Waste Bottles Issue

Reason for Correction

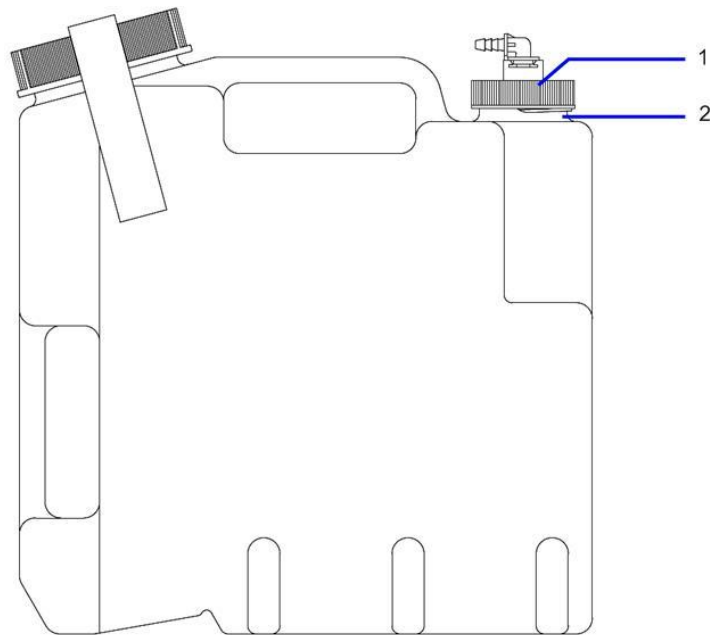
Figure 1. Water Bottle Assembly

Siemens has identified that the water and liquid waste bottle assemblies were manufactured with a quality issue. The smaller diameter opening of both bottles is undersized and/or deformed, preventing the cap from closing or fastening securely to the bottle.

-
- 1 Water bottle cap (38 mm) with an attached aspiration straw
 - 2 Water bottle small diameter opening
-

1. Install the water bottle onto the instrument.
2. Verify that the 38 mm cap is securely fastened onto the water bottle. This will ensure that the aspiration tubing attached to the cap reaches the bottom of the water bottle. Refer to Figure 1.

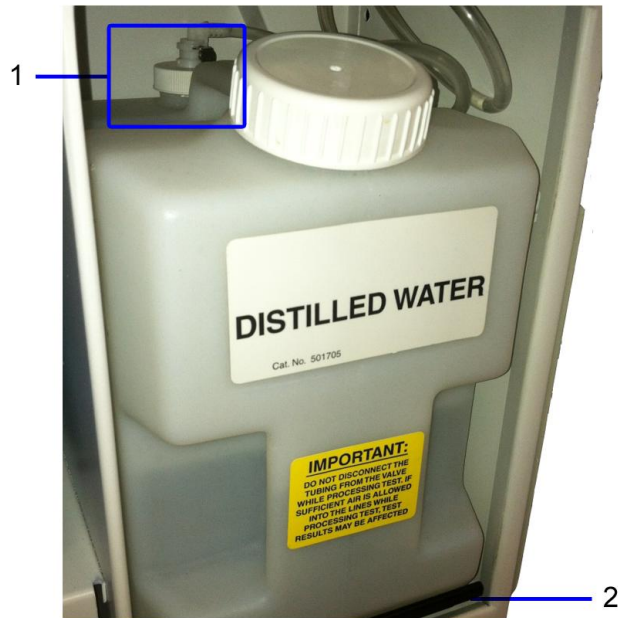
Figure 2. Securely Fastened 38 mm Water Bottle Cap

-
- 1 Water bottle cap (38 mm) securely fastened
 - 2 Water bottle assembly properly seated in compartment
-

4. After refilling is completed and the water bottle placed back onto the instrument, verify that the cap remains securely fastened. Refer to Figure 2.

6. Periodically verify that the 38 mm cap remains securely attached to the water bottle during instrument operation. Refer to Figure 2.
7. If the 38 mm cap is dislodged from the water bottle, perform the following:

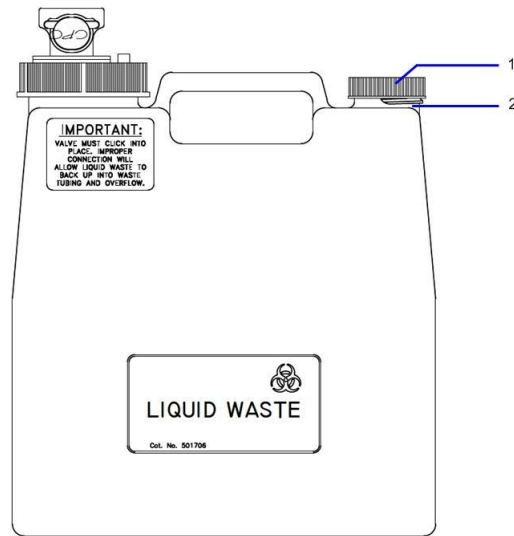
Figure 4. Liquid Waste Bottle Assembly

The small opening is used to pour waste from the bottle. If the cap dislodges during transport of a full bottle, care must be taken to avoid spillage.

-
- 1 Liquid waste bottle cap (38 mm)
 - 2 Liquid waste bottle small diameter opening
-

Ensure when transporting the Liquid Waste Bottle (Figure 4) that you are wearing appropriate Personal Protective Equipment (PPE). There are no other mitigation instructions as a defective liquid waste bottle will not disrupt test processing and there is no potential risk to health as long as you are wearing proper PPE.
