Dako reference number: CAPA00475

Urgent Medical Device Field Safety Notice

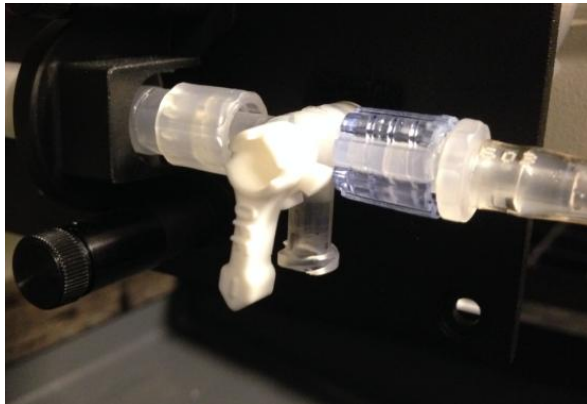
Dako has determined that a defect in the stopcock component of the syringe assembly (see figure 1) in some Autostainer instruments may, under some circumstances, cause leakage of excess buffer onto slide position 35 and 36 (for AS480 slide position 34) due to the stopcock's standby location over these position(s).

Figure 1. Picture of stopcock spare part to Autostainer

- Discontinue the use of HercepTest™ on the affected slide position(s).
- As set forth in Dako's staining protocol, use on-slide positive controls.
- Watch for any indication of buffer leakage from the syringe assembly. This can be done easily when the tubes are checked for air bubbles in connection with exchange of the buffer bottle.
- Check for weak staining in regards to HercepTest™ in the affected slide position(s). As advised in the IFU for HercepTest™ please contact Dako Technical Support Department to report unusual staining.

Dako has identified a longer term corrective action to install a drip tray under the stopcock. Your local Dako representative will contact you when the drip tray is available.
