CH-3110 Münsingen, March 27, 2017

FIELD SAFETY NOTICE

PREVENTIVE CORRECTIVE ACTION CONCERNING SCHAEERER ARCUS 501-701 SURGICAL TABLES

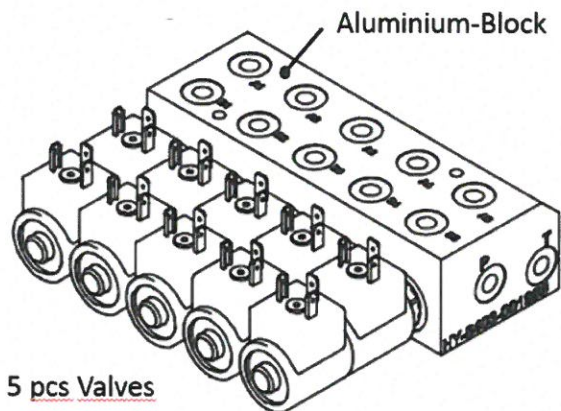
Figure 1: Large Valve Block arcus

During routine quality control procedures of the large valve block at the supplier's factory, inaccurate, out of spec drill holes were discovered. The drill holes serve as positioner for the hydraulic valves, which control the flow of hydraulic oil through the hydraulic system and thus the movements of the components of the table, such as height column, lateral tilt, Trendelenburg, seat section and leg section.

The inaccurate drill holes may result in damage of the valves, which may result in malfunction of the table. Damaged valve sealing may result an uncontrolled flow of hydraulic oil which may result in a loss of pressure in the hydraulic tubes and subsequently the cylinders are not controlled correctly

anymore. This may result in a complete blocking of the surgical table in the current position, which may result in a critical situation for the patient. The patient would need to be taken off the surgical table and repositioned on a back up table.

Every customer will be contacted by the Schaerer Medical Customer Service and the affected large valve blocks will be replaced/ exchanged. Please keep this FSCA Information on file at least until the measures taken are fully completed.

Schaerer Medical will provide replacement parts and instructions for the replacement. Please contact the customers according to the serial numbers and ensure the replacement of the large valve blocks in due course.

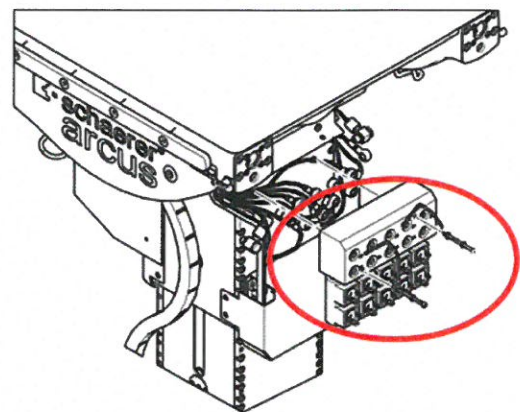
Figure 2: Position of Valveblock inside the table at the top end of the column
